Chapter 8 RESNET Standards

800 RESNET Standard for Performance Testing

802 General Provisions for Thermographic Inspections of Buildings

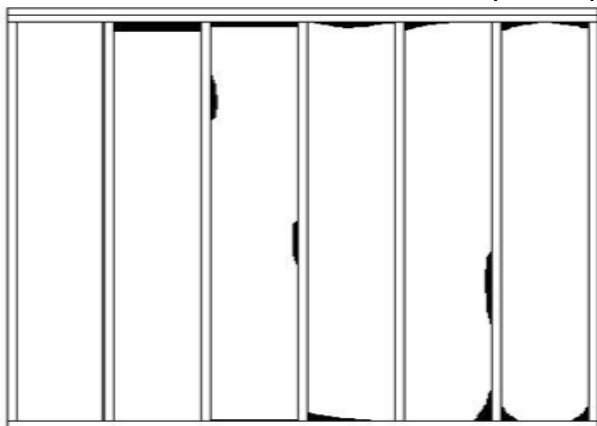
Grade II must be insulation installed with anomalies found to be between 1/2% and 2% for all inspected walls, floors and ceilings of the building.

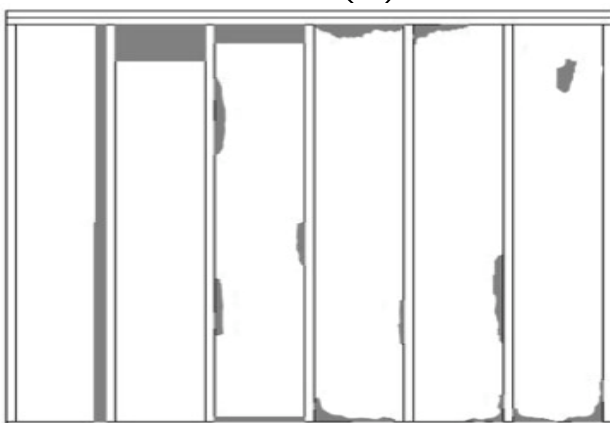
Grade III must be an insulation installation having between 2% and 5% anomalies found for all inspected walls, ceilings and floors of the building enclosure.

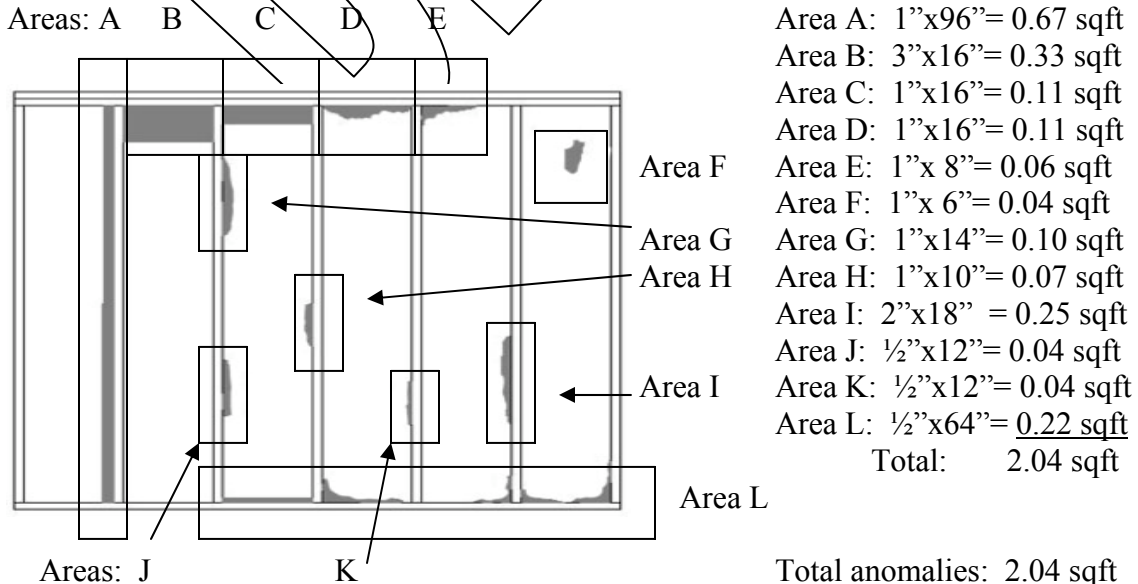
Grade III Example

2.04 sqft / 64 sqft = 0.0375
or 3.75%

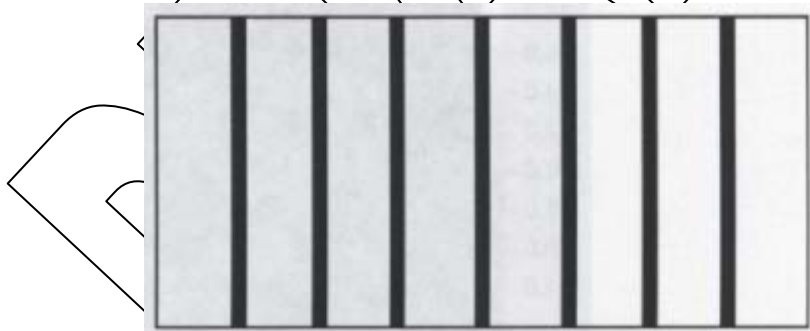
1. Different thermal patterns occur as a result of differing wall conditions, which must be identified for proper interpretation of the thermographic images. Without knowing the exact conditions you are viewing with the camera (summer/winter, inside/outside, transient state/steady state), you cannot make the proper interpretation of the thermogram. The following general descriptions of exterior walls do not take into account any obstructions, which may be within the wall cavities.
 - a. The wall below with warm (lighter) wall cavity areas and cold (darker) framing materials could be one of the following:
 - Uninsulated, when viewed from outside during the heating season.
 - Insulated, when viewed from inside during the heating season.
 - Insulated, when viewed from the outside during the cooling season.
 - Uninsulated, when viewed from the inside during the cooling season.

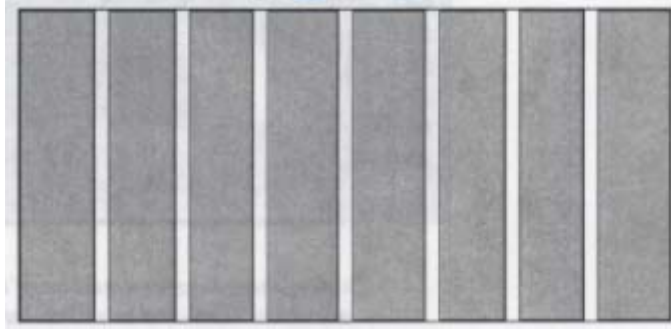
- b. The wall below with darker (cooler) wall cavity areas and warmer (lighter) framing materials could be one of the following:
 - Insulated, when viewed from the outside during the heating season.
 - Uninsulated, when viewed from the inside during the heating season.
 - Uninsulated, when viewed from the outside during the cooling season.
 - Insulated, when viewed from the inside during the cooling season.
