Explaining the Thermal Bypass Checklist

**Ed Minch,
Energy Services Group
Kelly Parker, GWS**

Thermal Bypass Checklist – WHY?

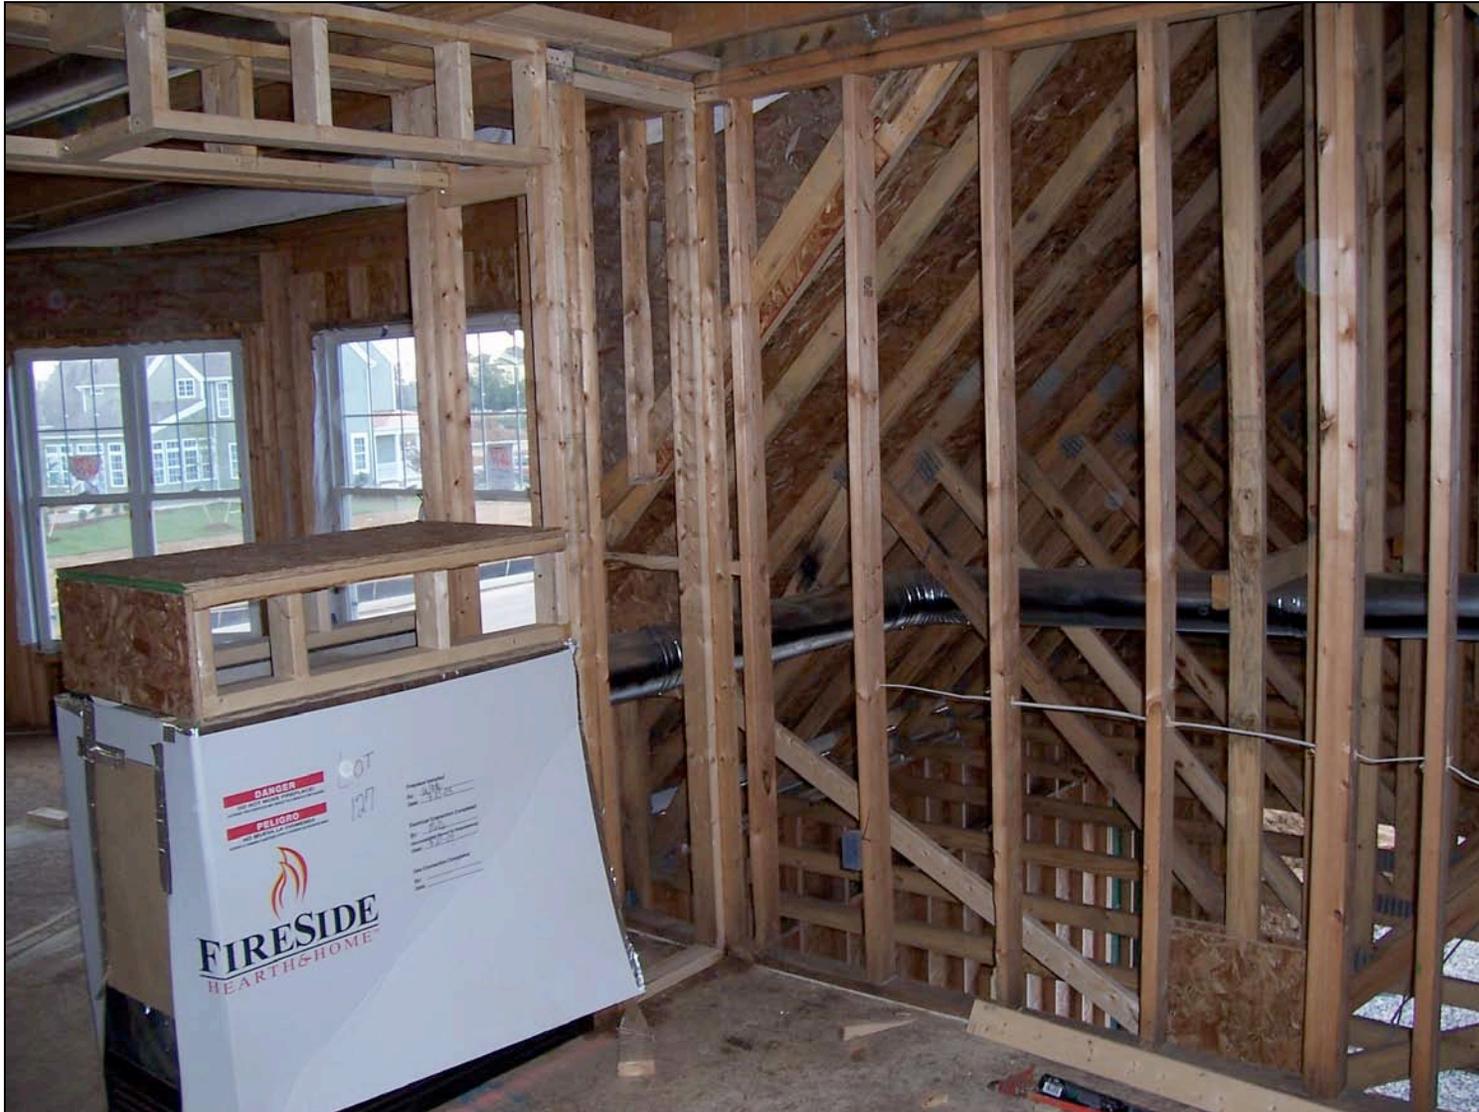
1) Air barrier and Thermal Barrier in Alignment

Insulation is installed in full contact with the air barrier to provide continuous alignment of the insulation with the air barrier

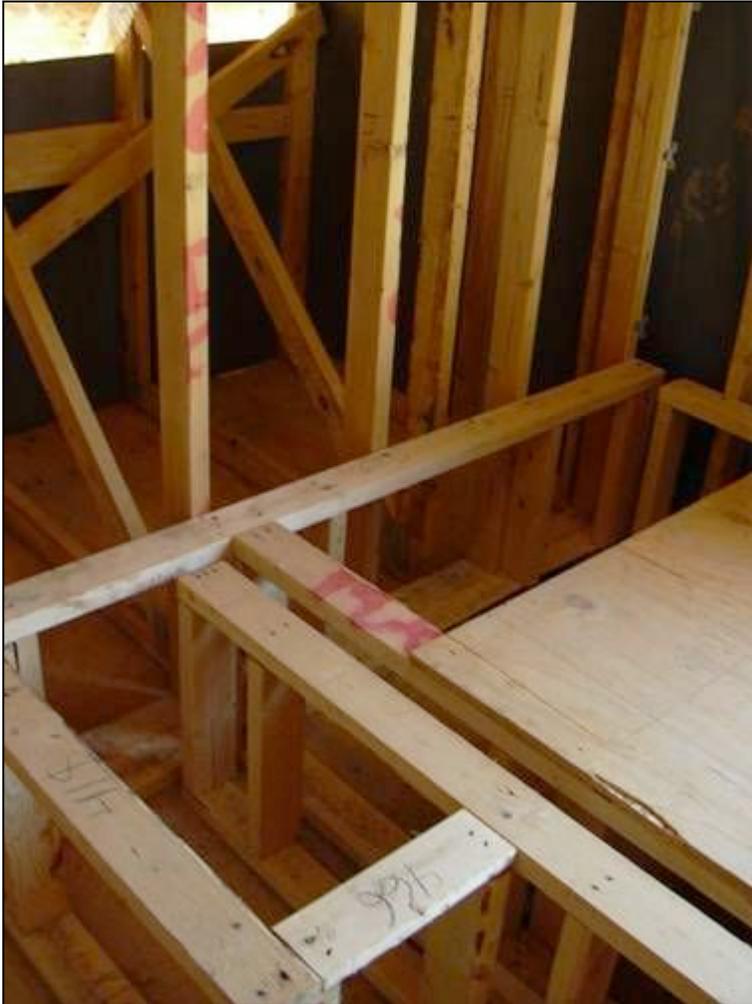
Soaking tub base open to
knee wall attic

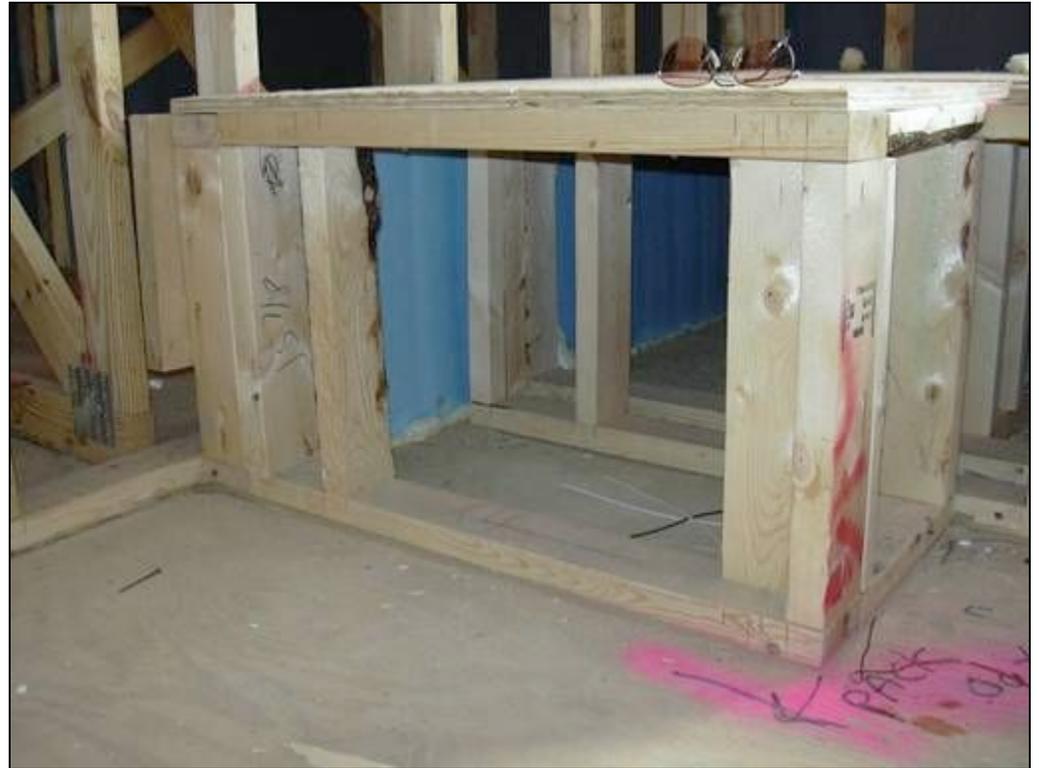
Sealed tight

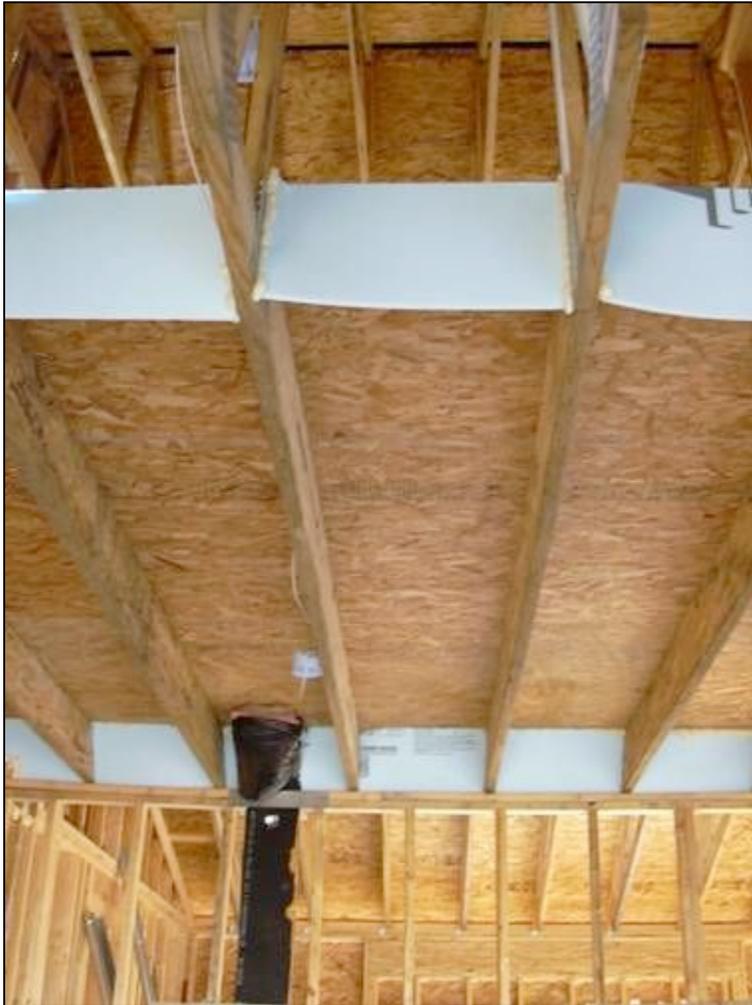
Air dams at both ends of open joists
under room over garage

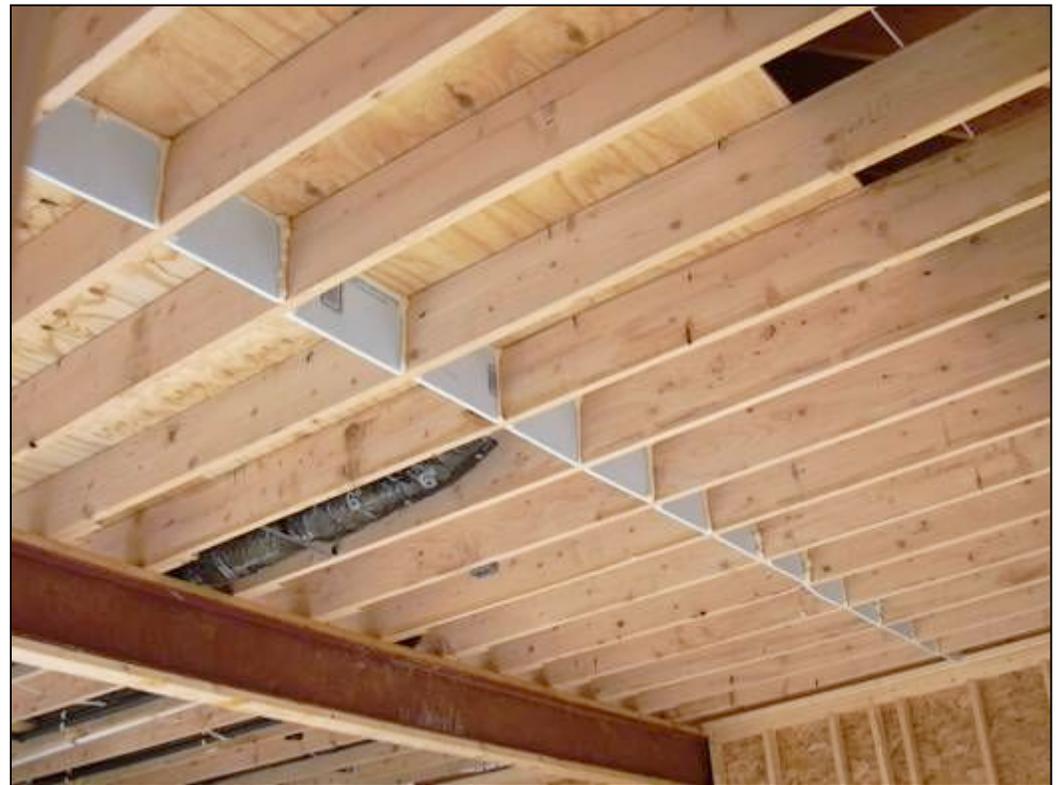
Air dams under exterior wall of room
above garage

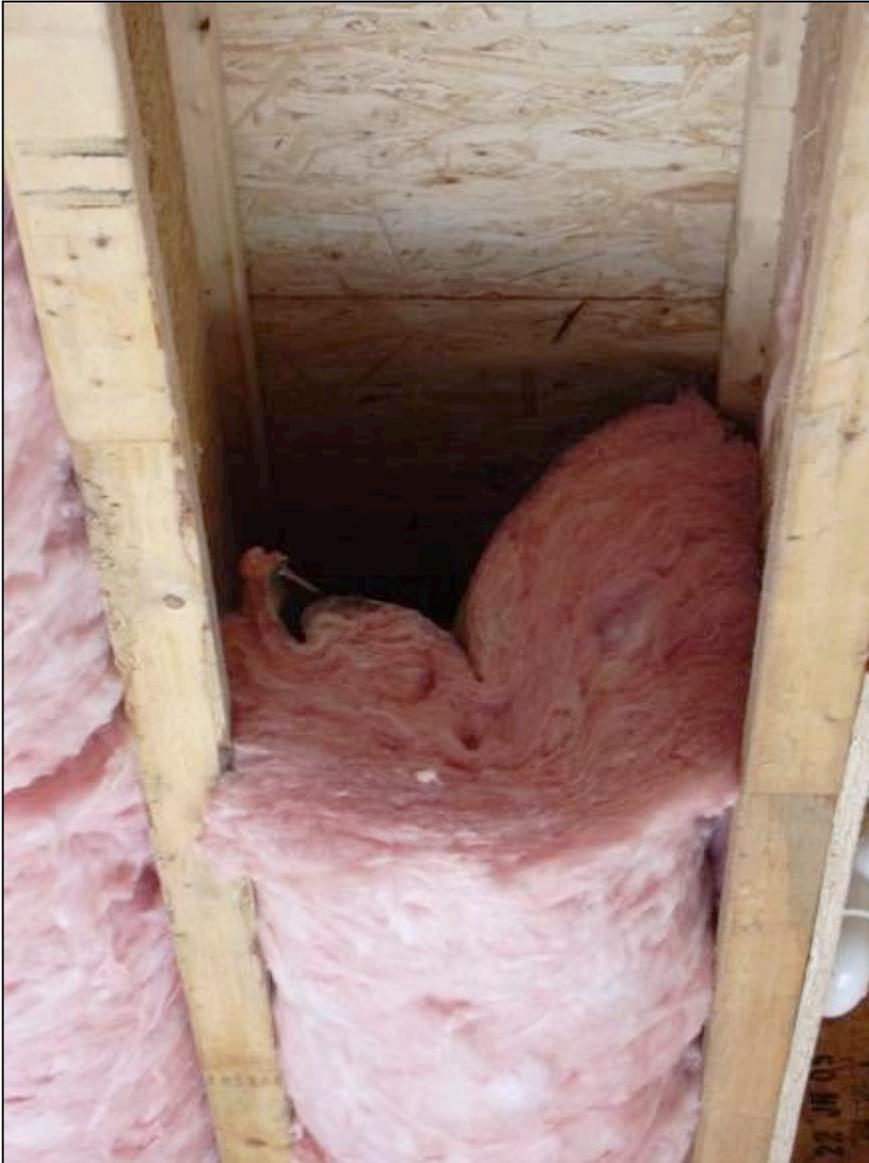
Improper insulation!
It must touch the surface it is intended to insulate

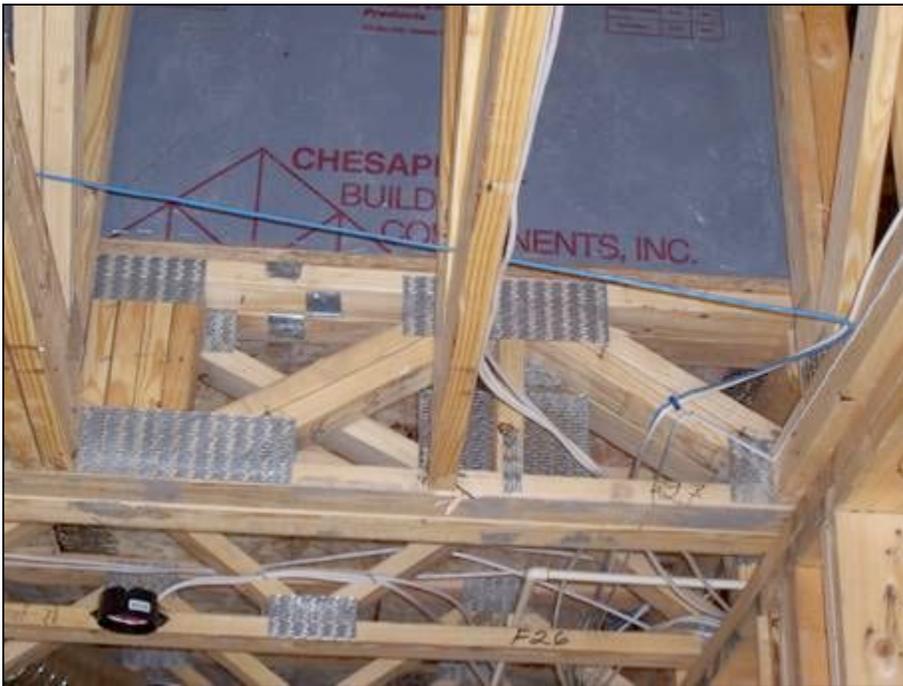
Air damming of the floor cavity below a kneewall.

6th side on the wall above.

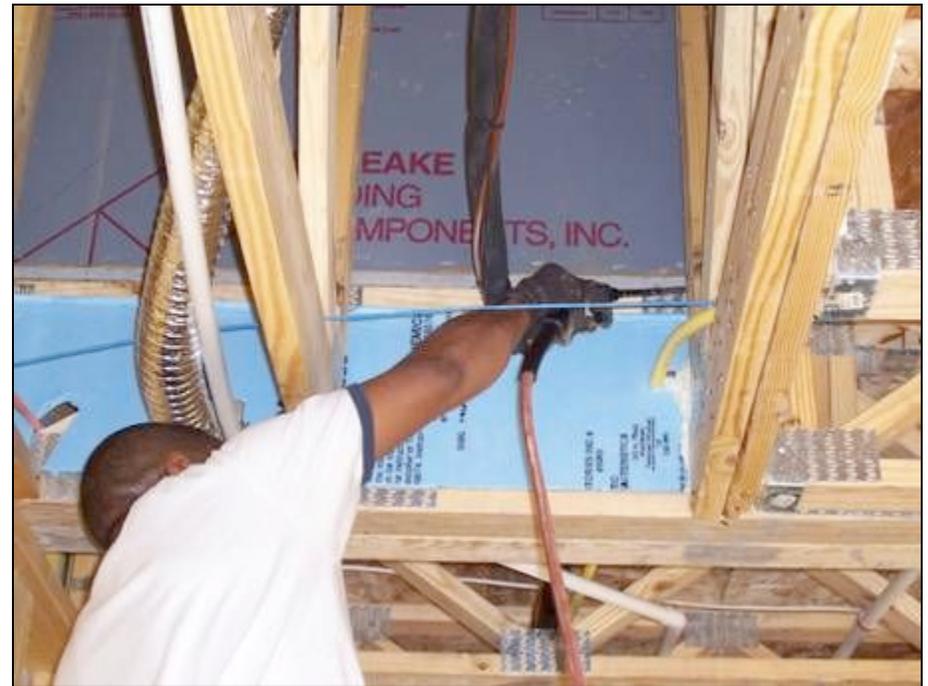
Sealed Tight.

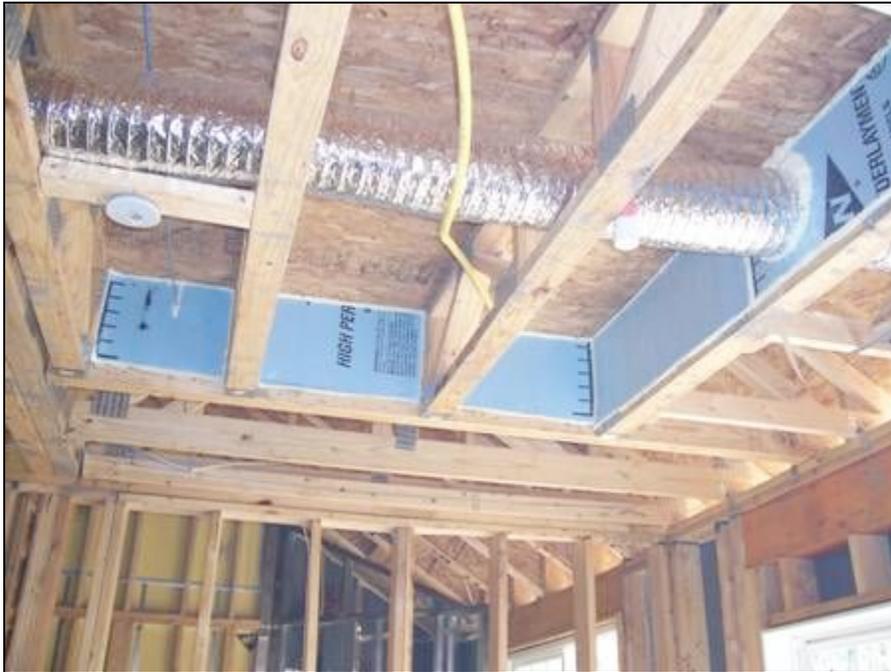
Joist cavity open to attic on 2 sides - sealed tight.

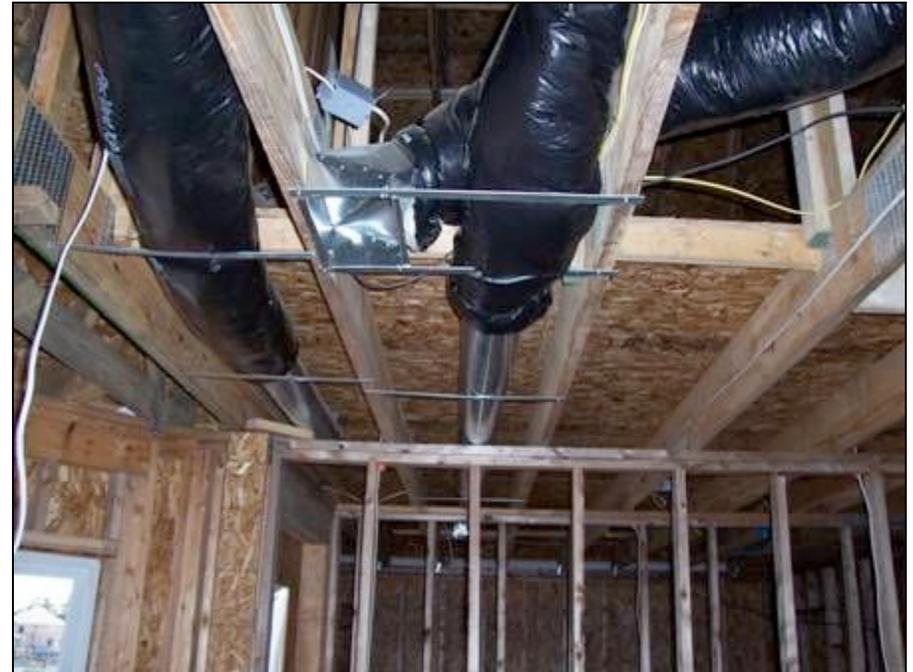
Looking into the second floor kneewall joist cavity.

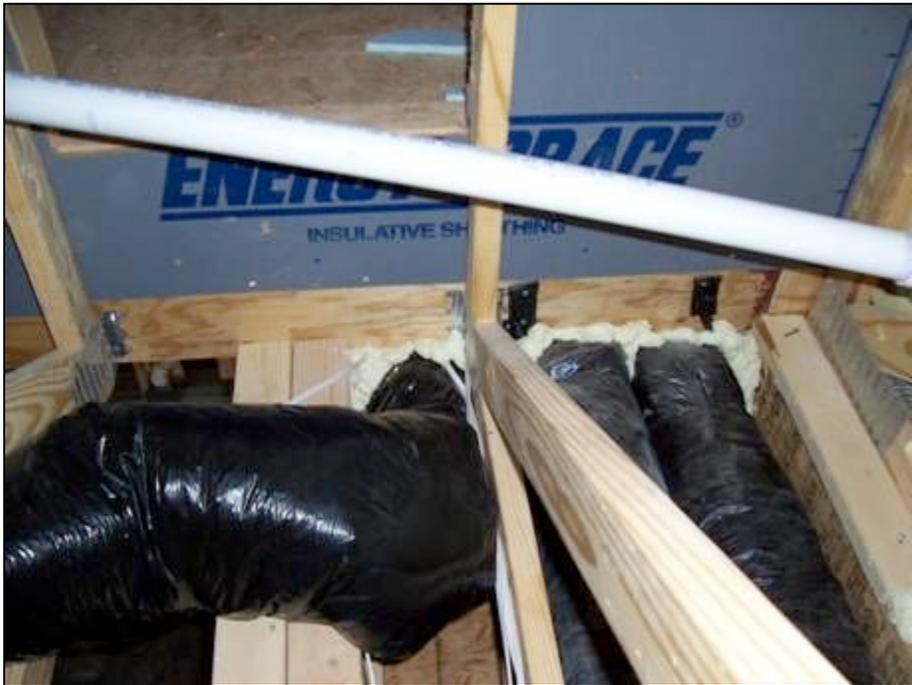
Tightly sealed ductwork.

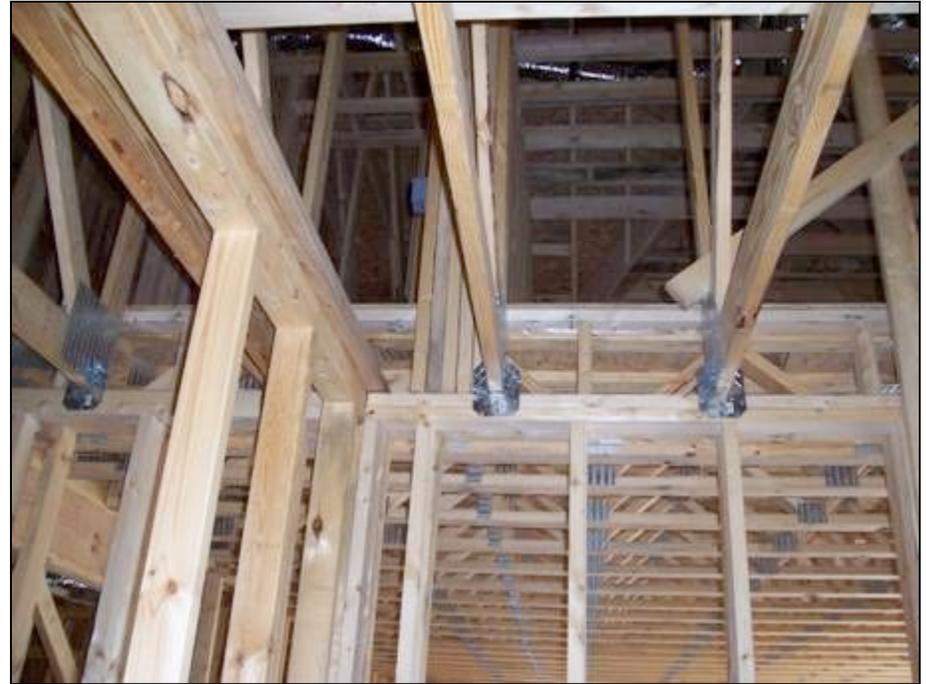
Looking from an attic kneewall into joist cavity.

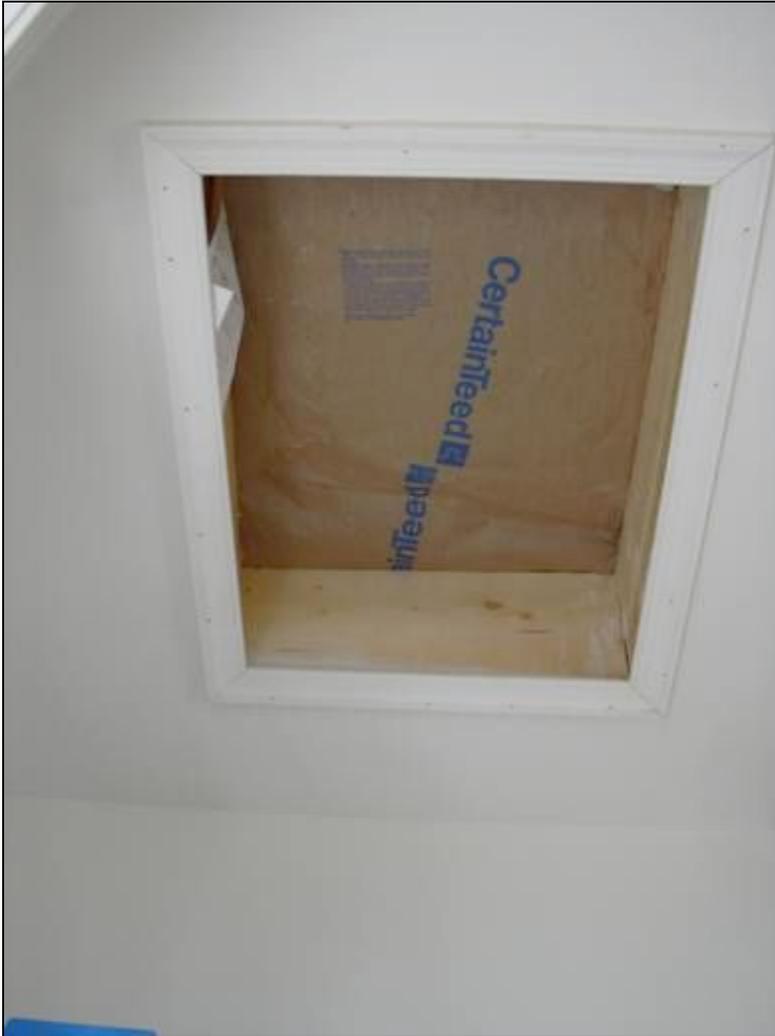
Wrong way to insulate - air barrier and insulation not aligned.

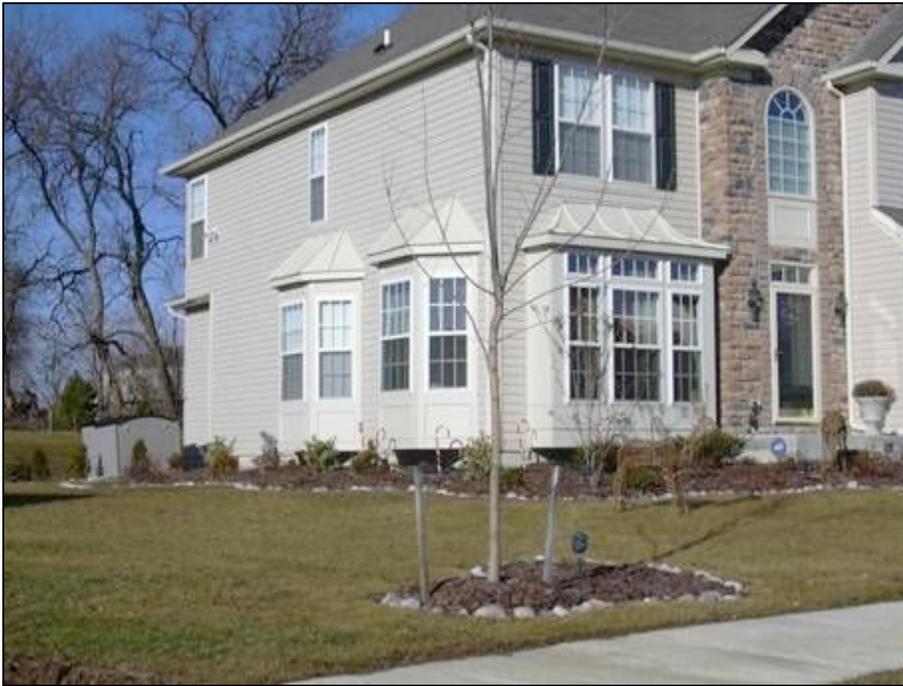
Three bay windows and a rear overhang.

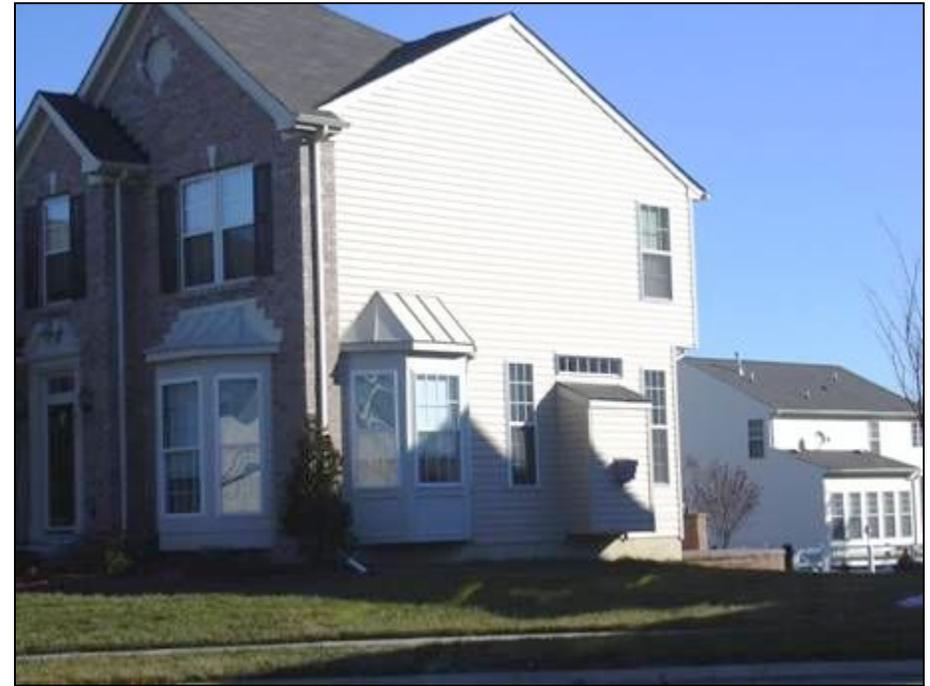
Two bay windows, a fireplace and rear overhang.

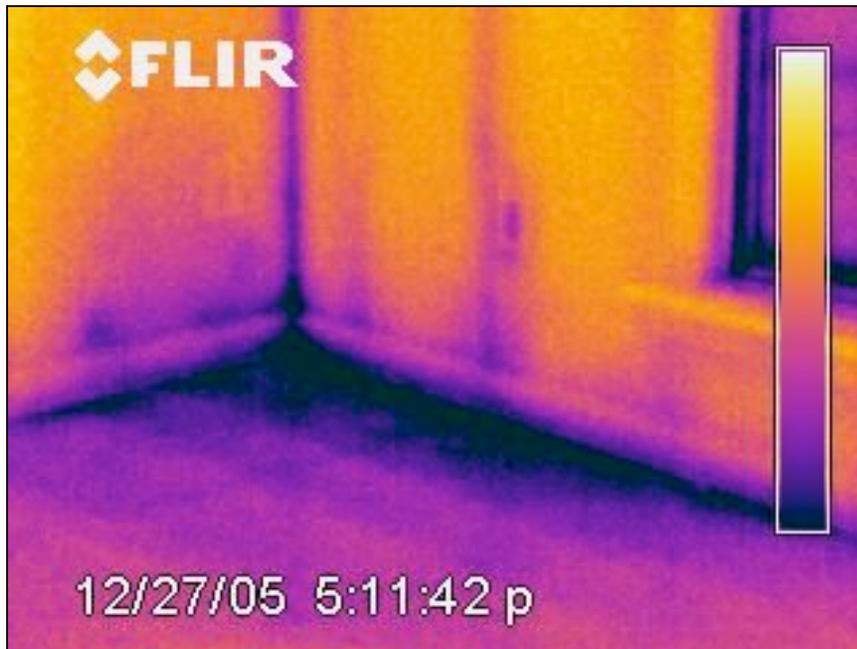
Cantilevered floor not sealed and not insulated properly.

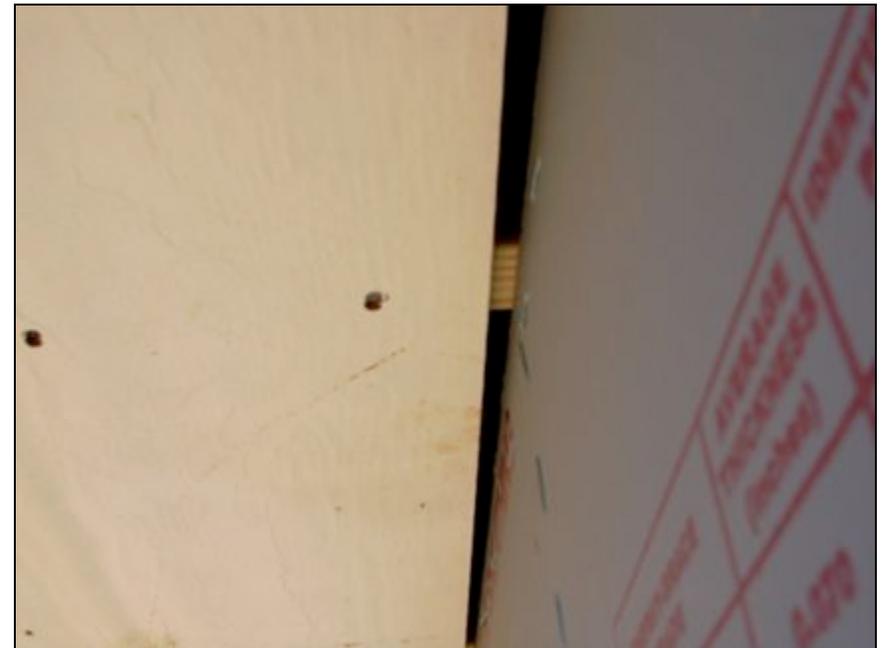
Cantilever before siding – “j” channel will hide this.

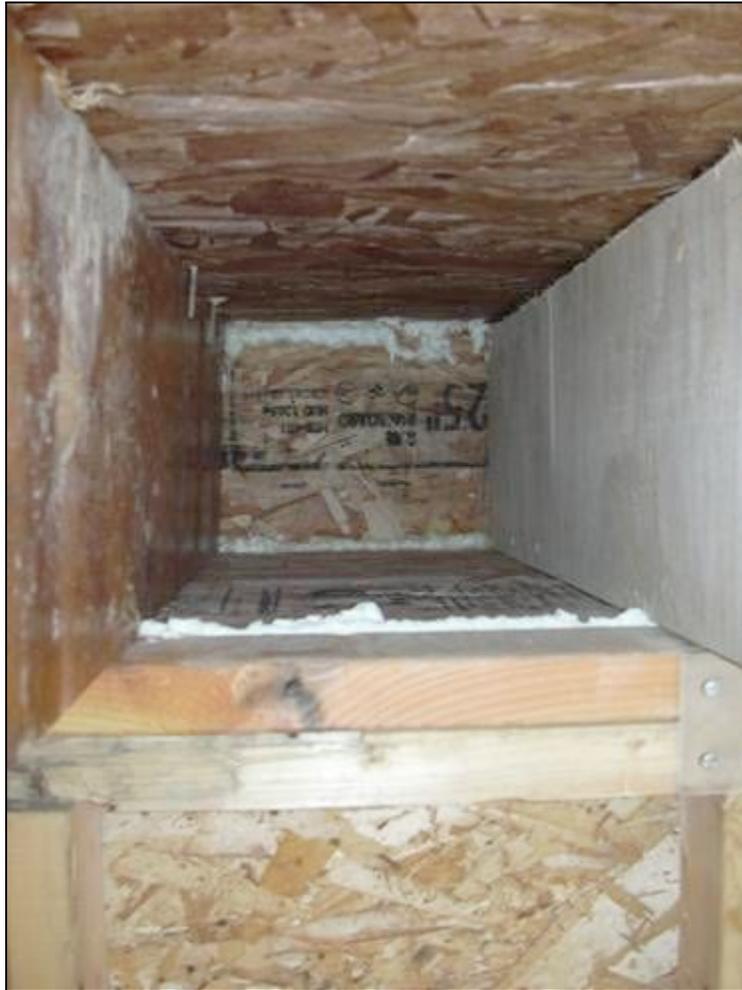
Tight seal - now insulation will be installed full-depth.

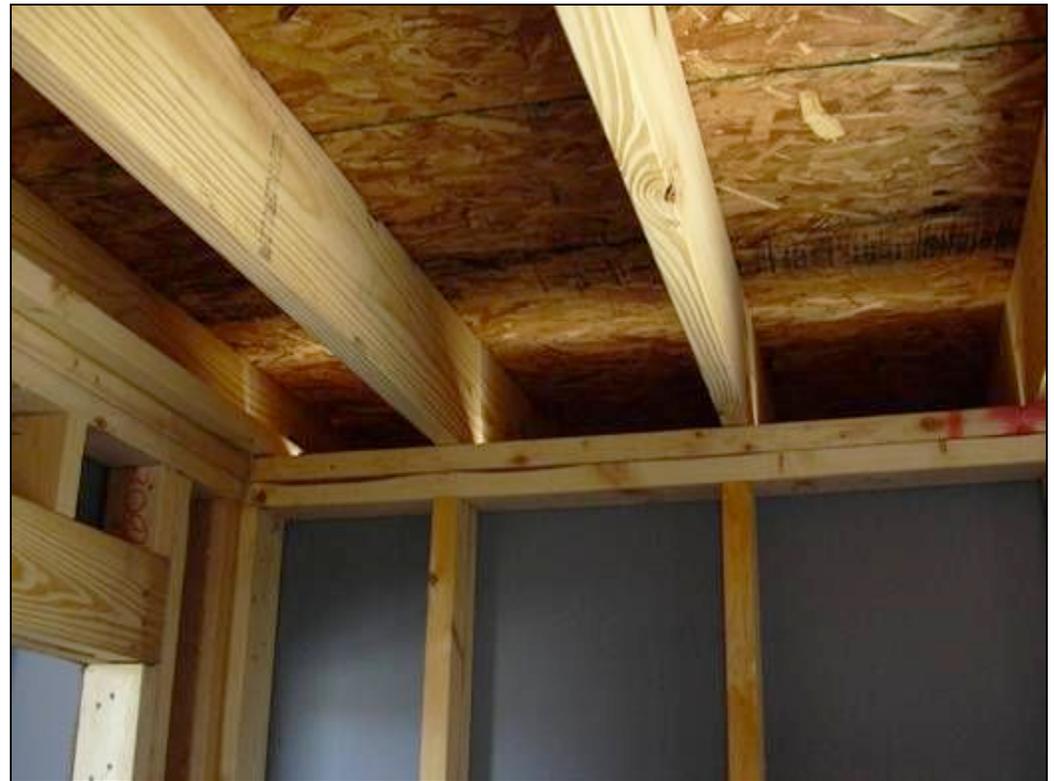
Daylight showing leaking cantilever.

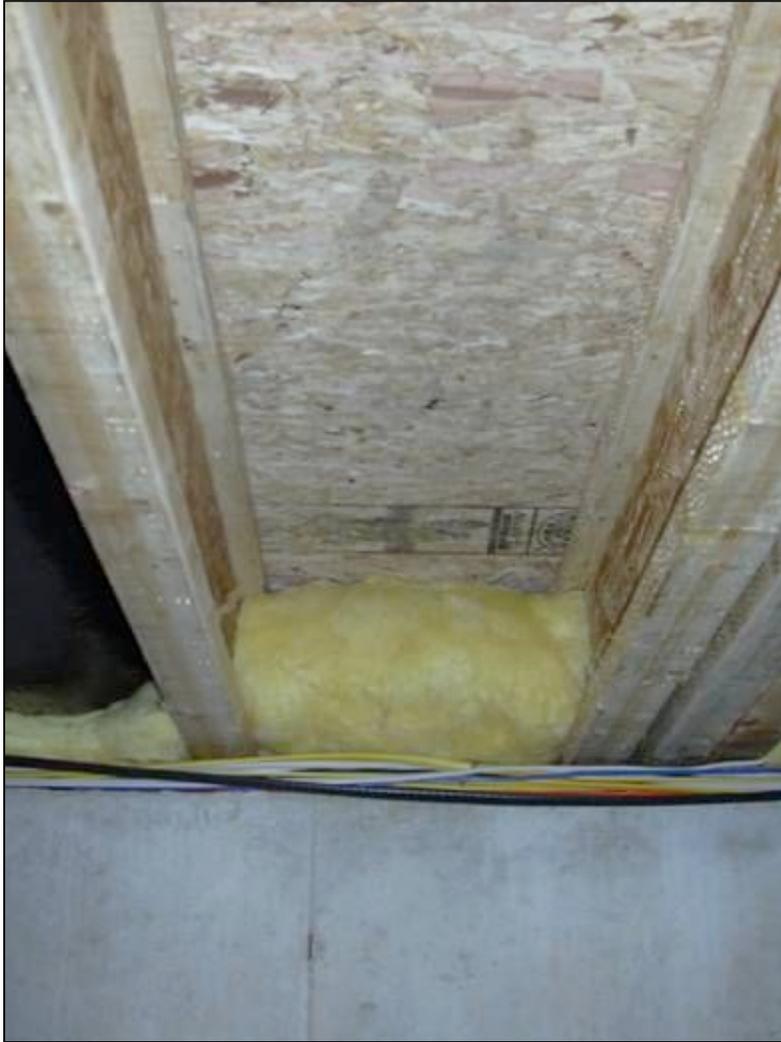
Insulation - full depth of floor joist.

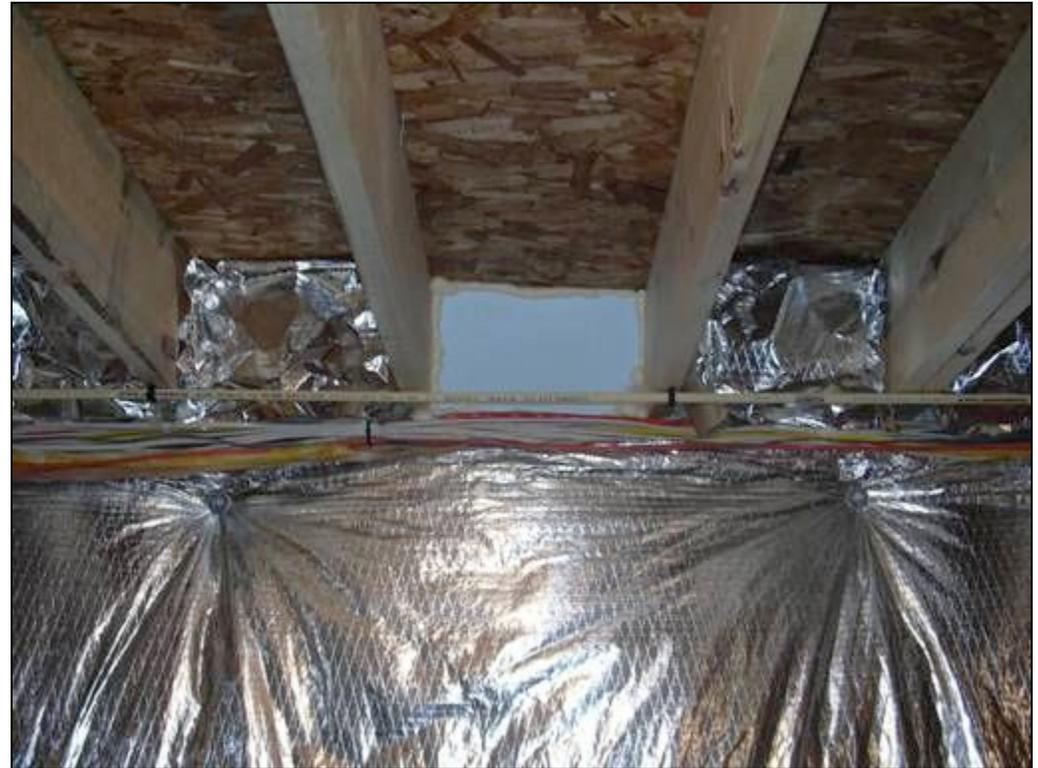
Alternative - overhang sealed and insulated first, then air dam sealed tight. In small overhangs, this tends to make floor colder.

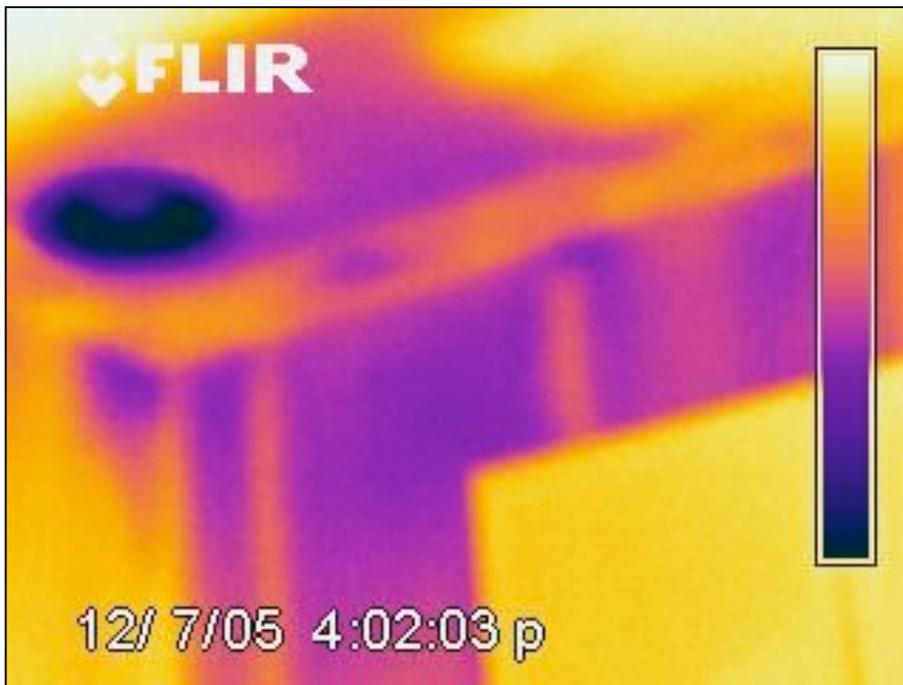
Chase open from attic into interior wall.

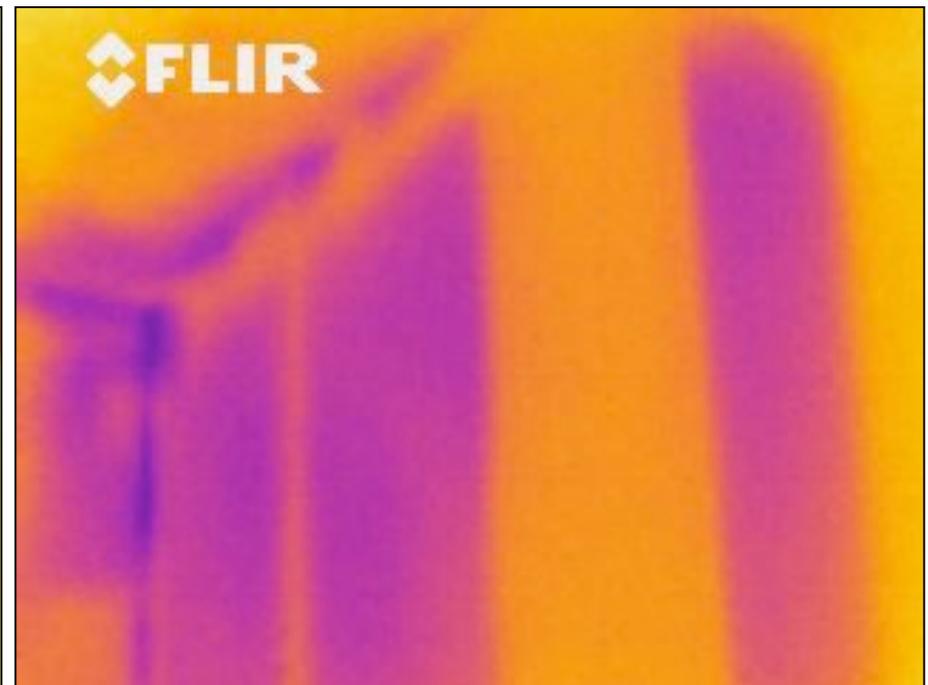
Typical chase, no metal collar at flue with improper flue clearance to OSB.

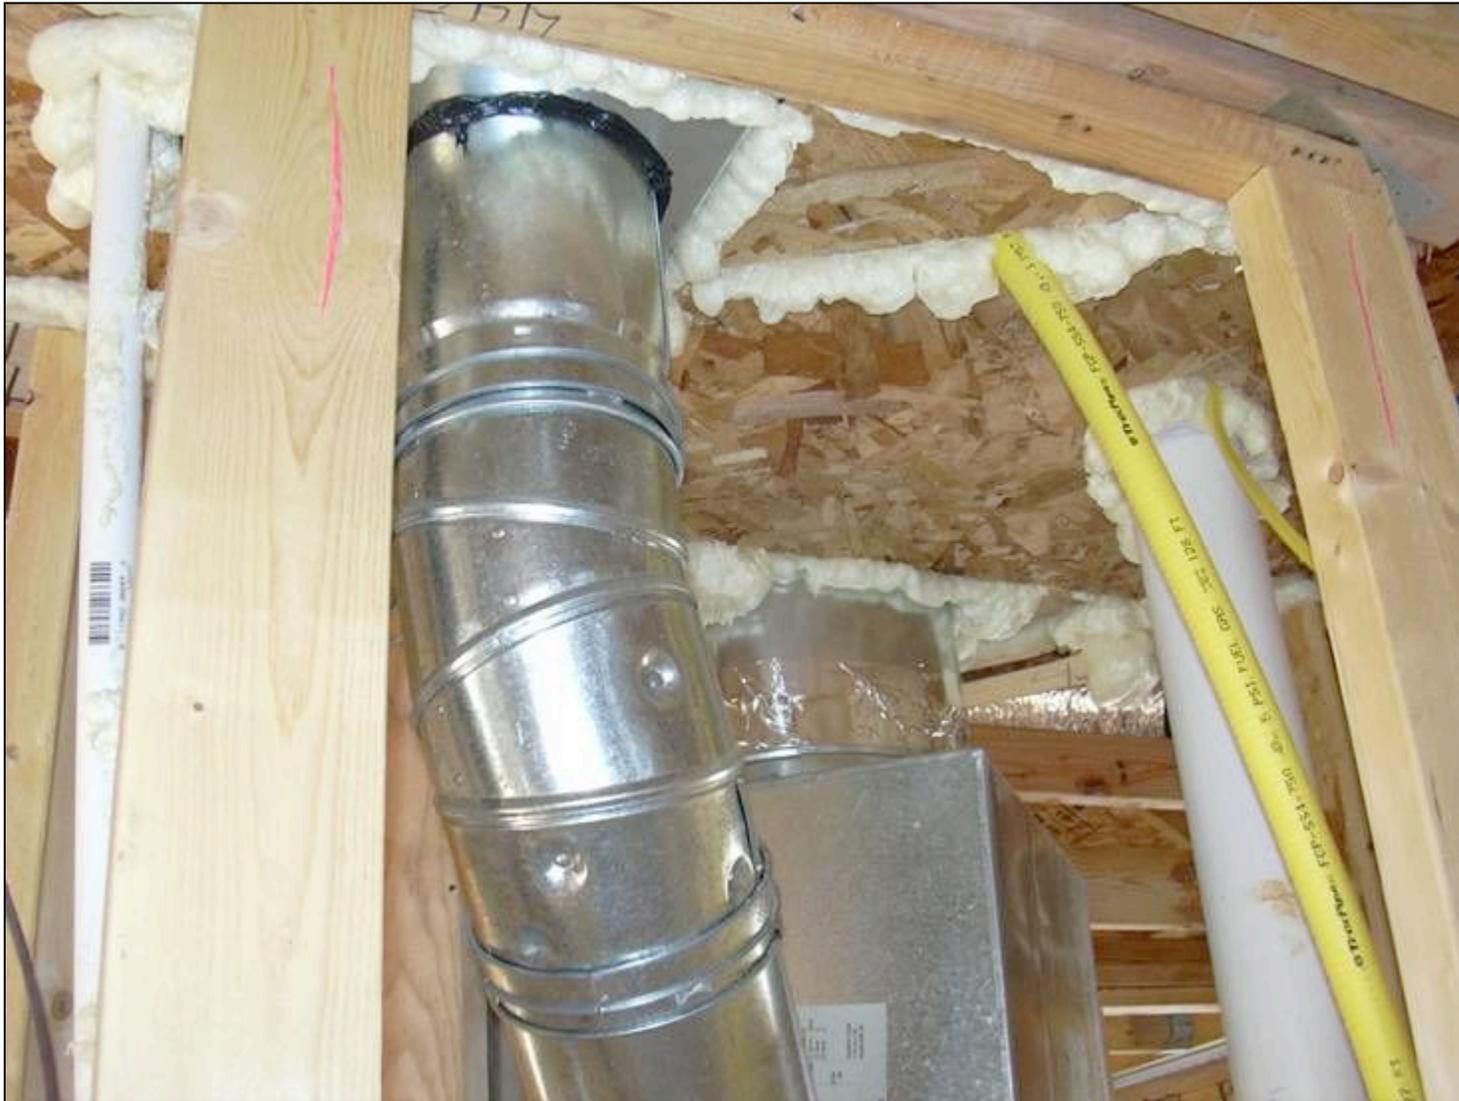
The mother of all chases.

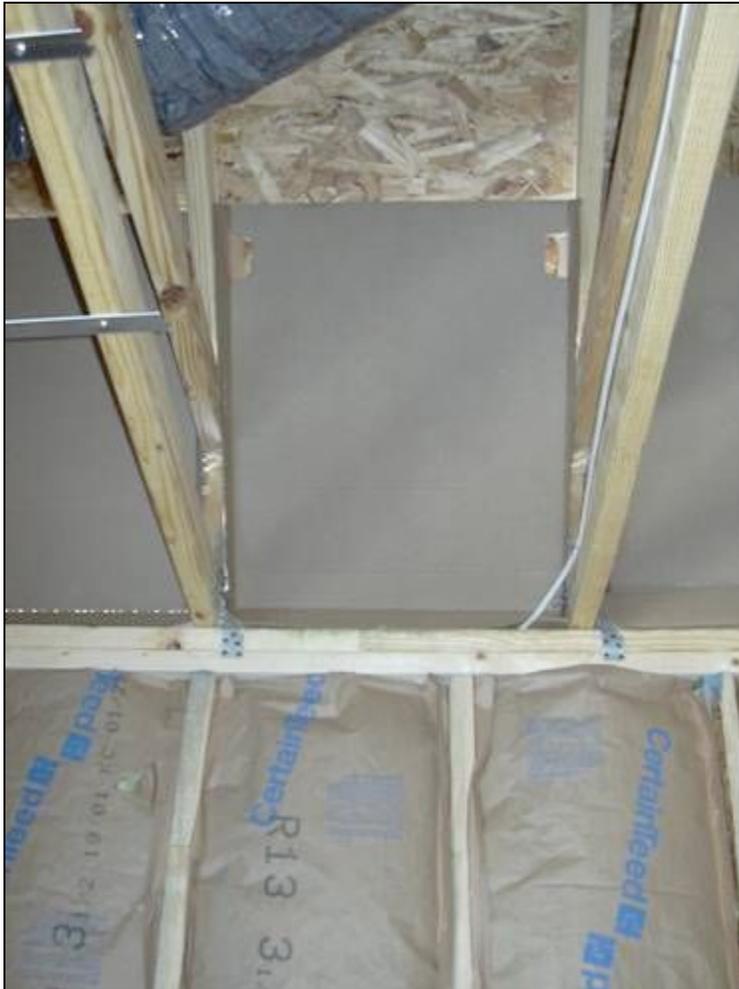
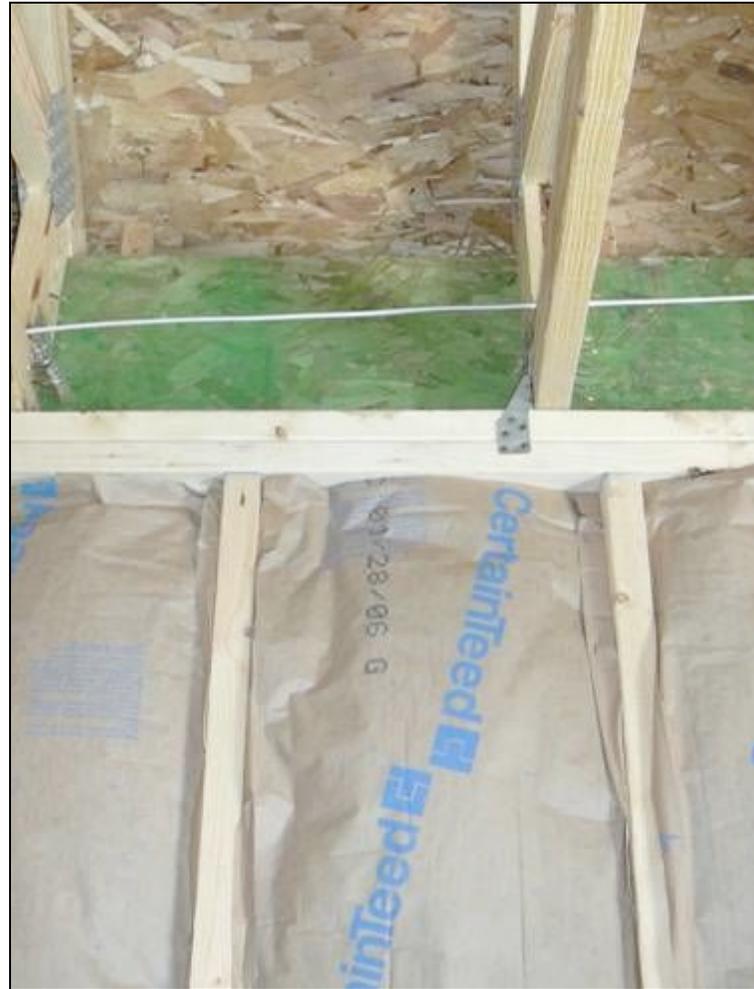
9) Attic Eaves

Solid baffles are provided at framing bays to avoid wind washing of insulation.

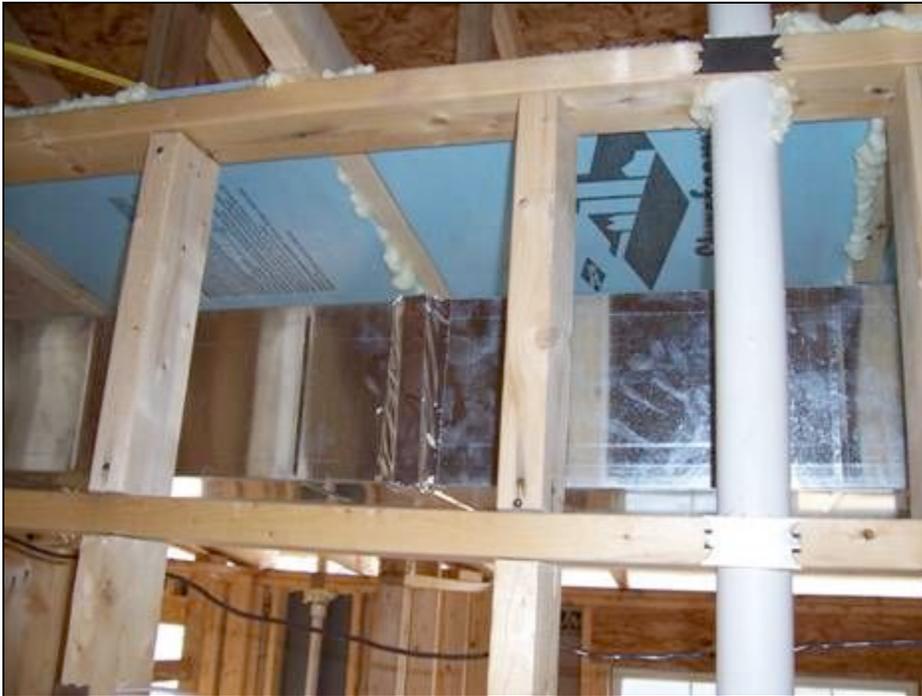
Duct soffit sealed with styrofoam and foam.

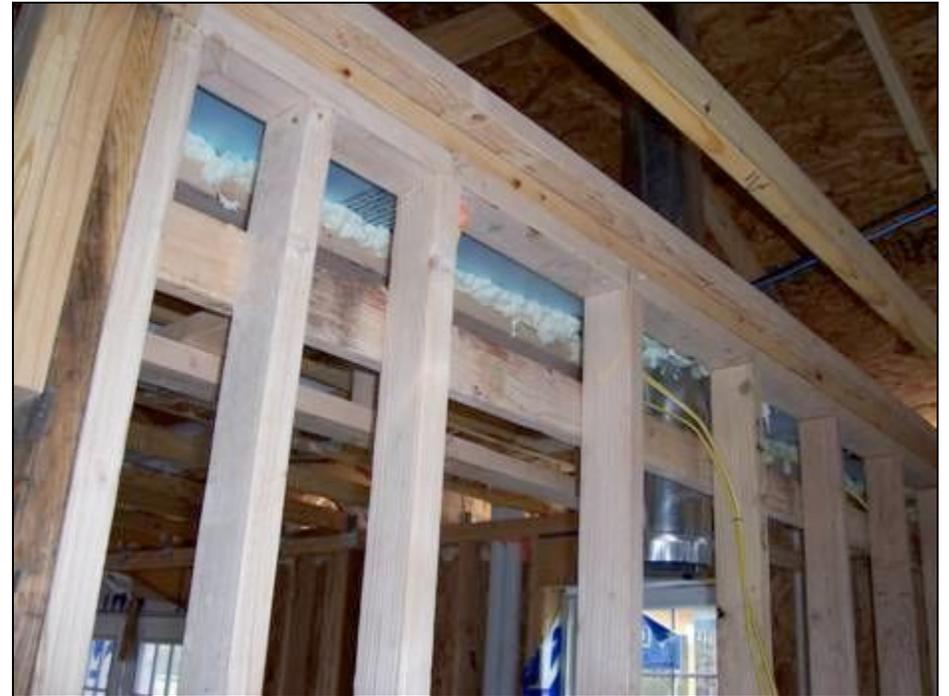
Kitchen soffit sealed with styrofoam and foam.

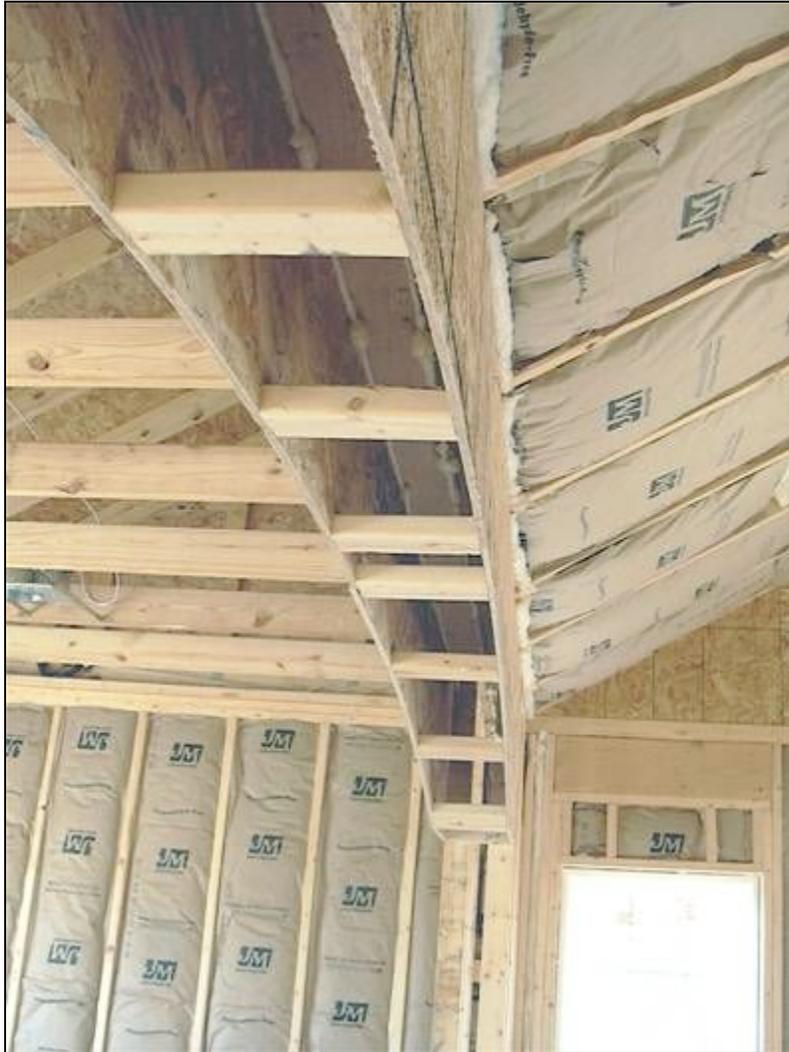
Archway between 2 rooms forming 'soffit' - sealed inside with foam.
