Explaining the Thermal Bypass Checklist

**Ed Minch,
Energy Services Group
Kelly Parker, GWS**

Thermal Bypass Checklist – WHY?

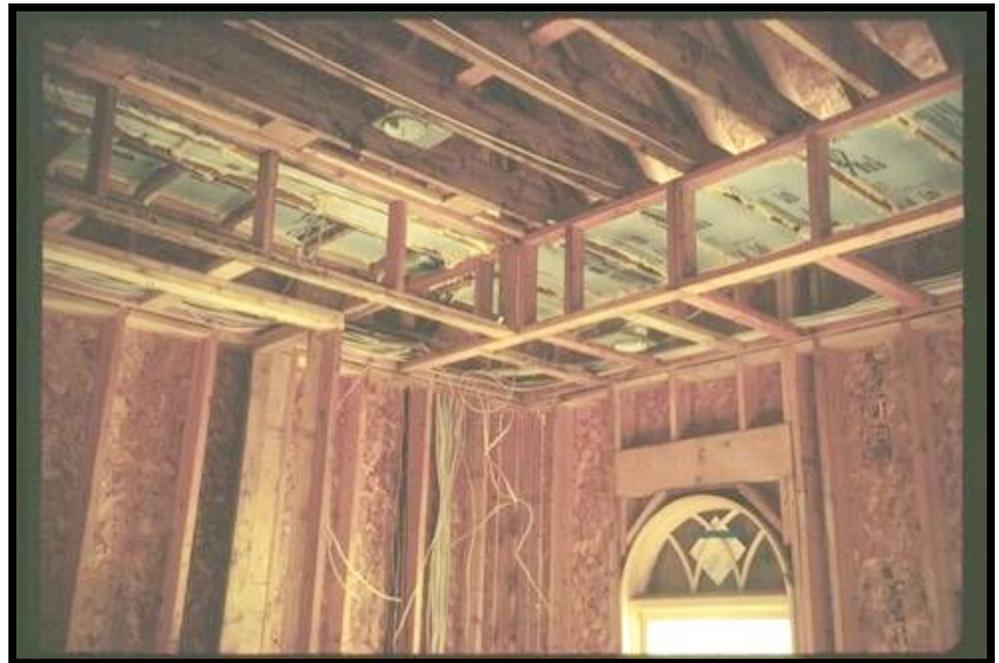
Kitchen soffit sealed at joist level with styrofoam & foam.

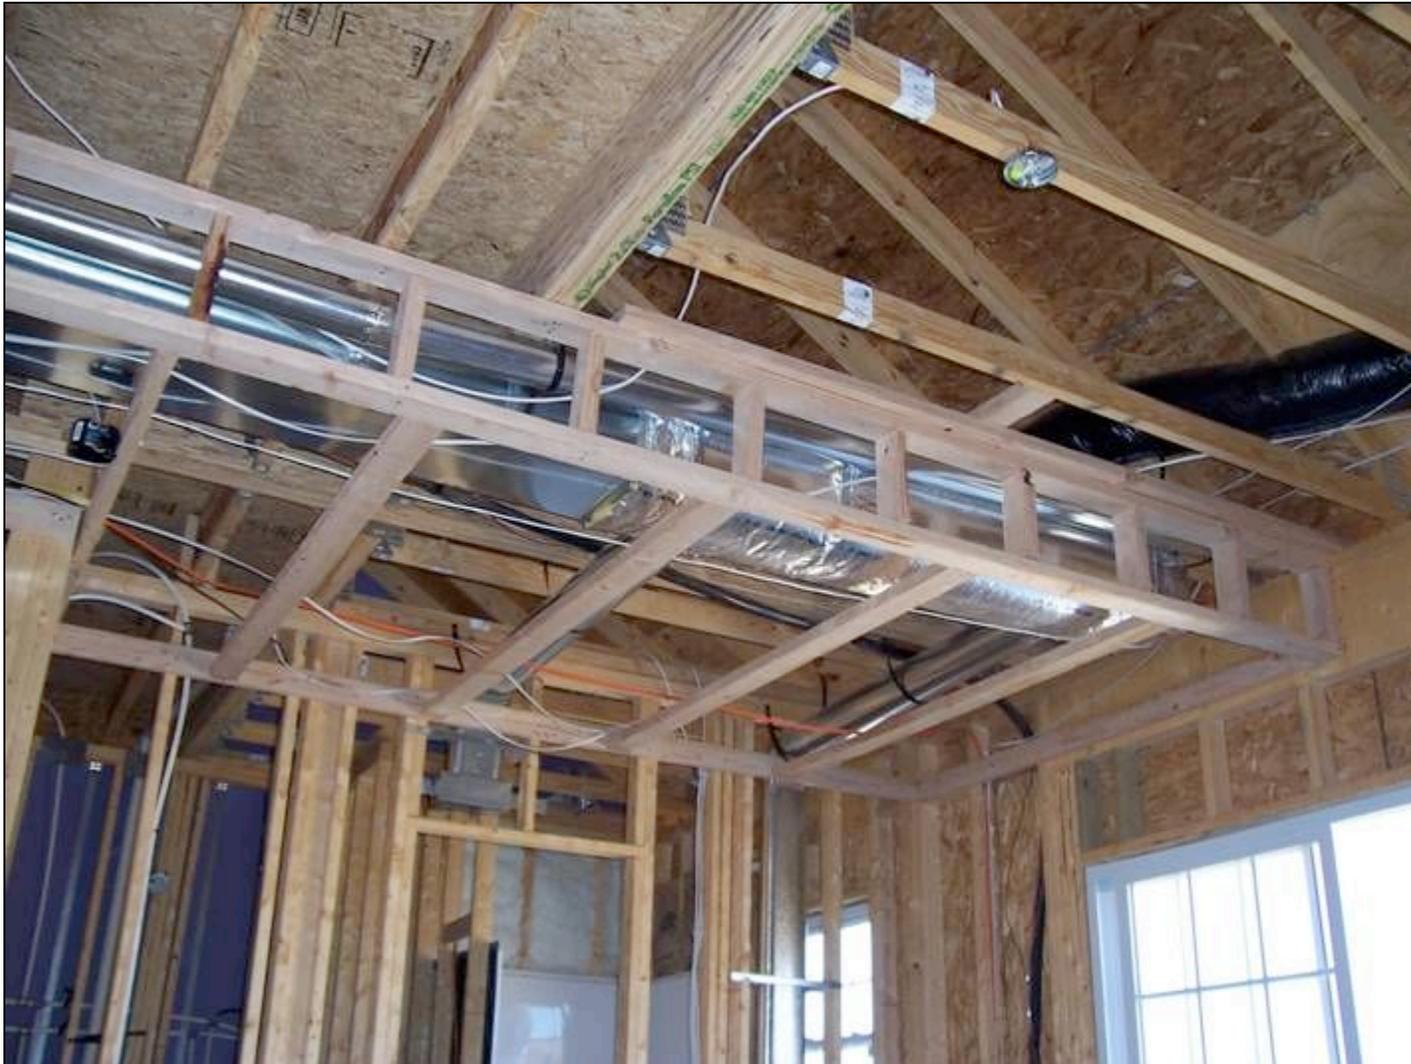
Very difficult soffit - under heated space and open to unheated space. Duct is insulated 'outside' and not 'inside', wire runs 'outside' to 'inside'. No thermal envelope.

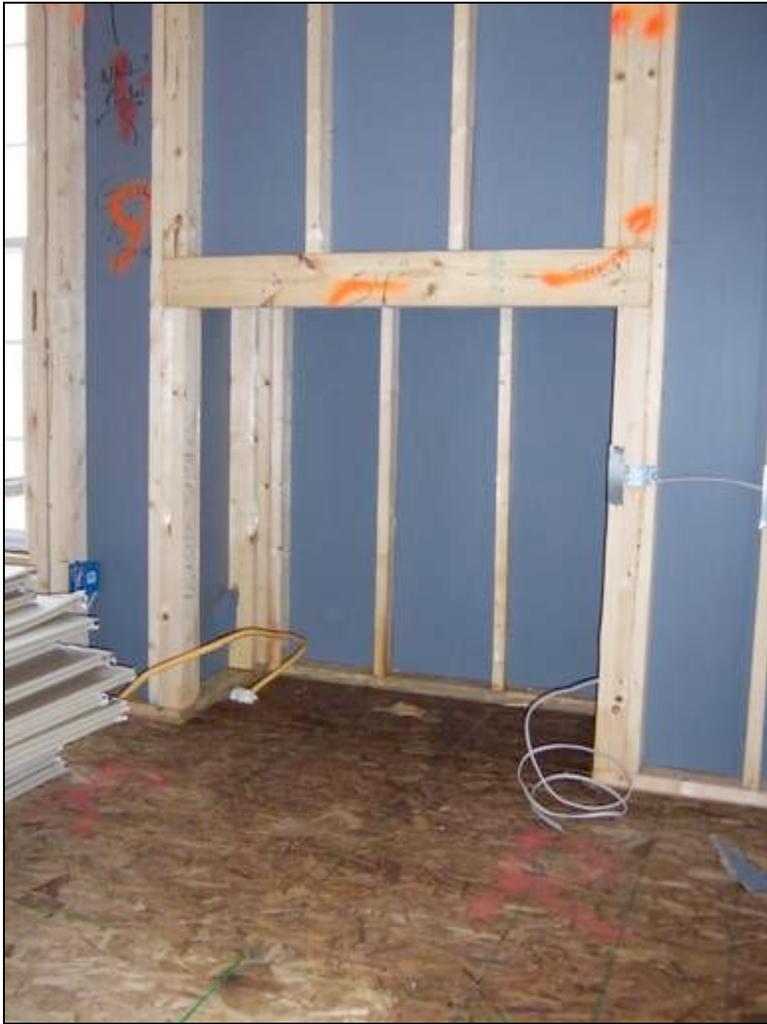
Typical fireplace chase. Treat this area like a little room. Every surface should be sealed & insulated.

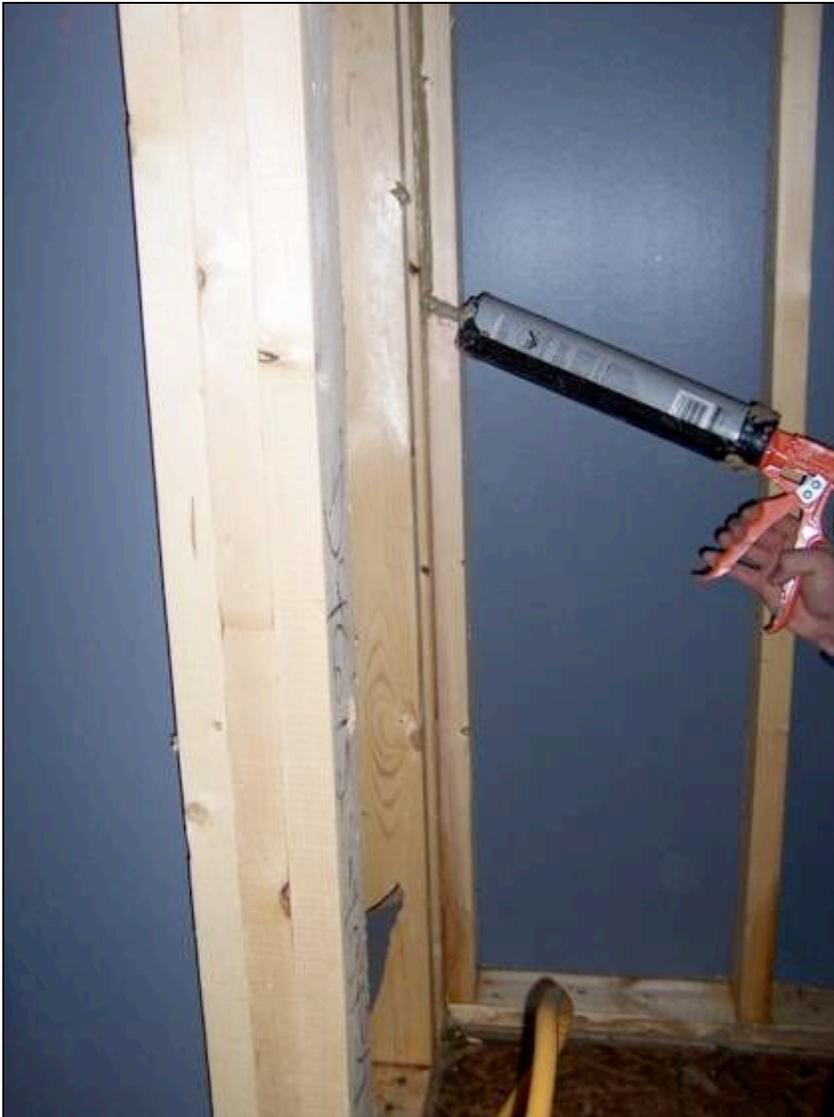
Seal every crack and hole in the chase.

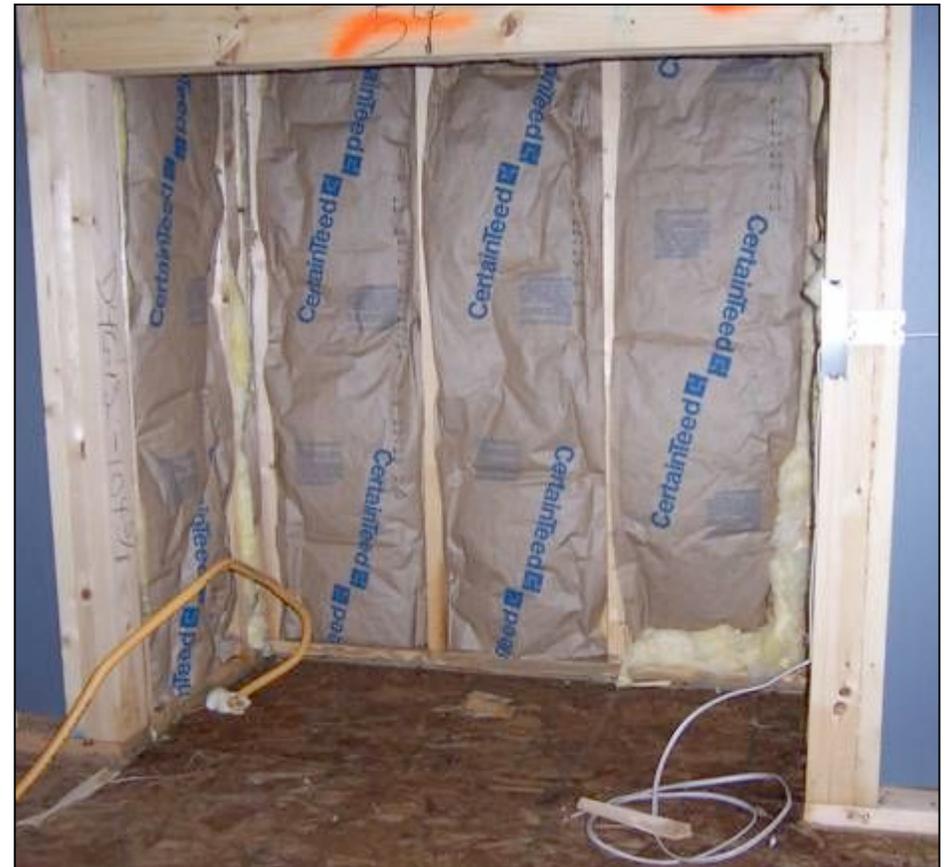
Insulate the walls. ceiling is already done and under the floor will be insulated from the basement.

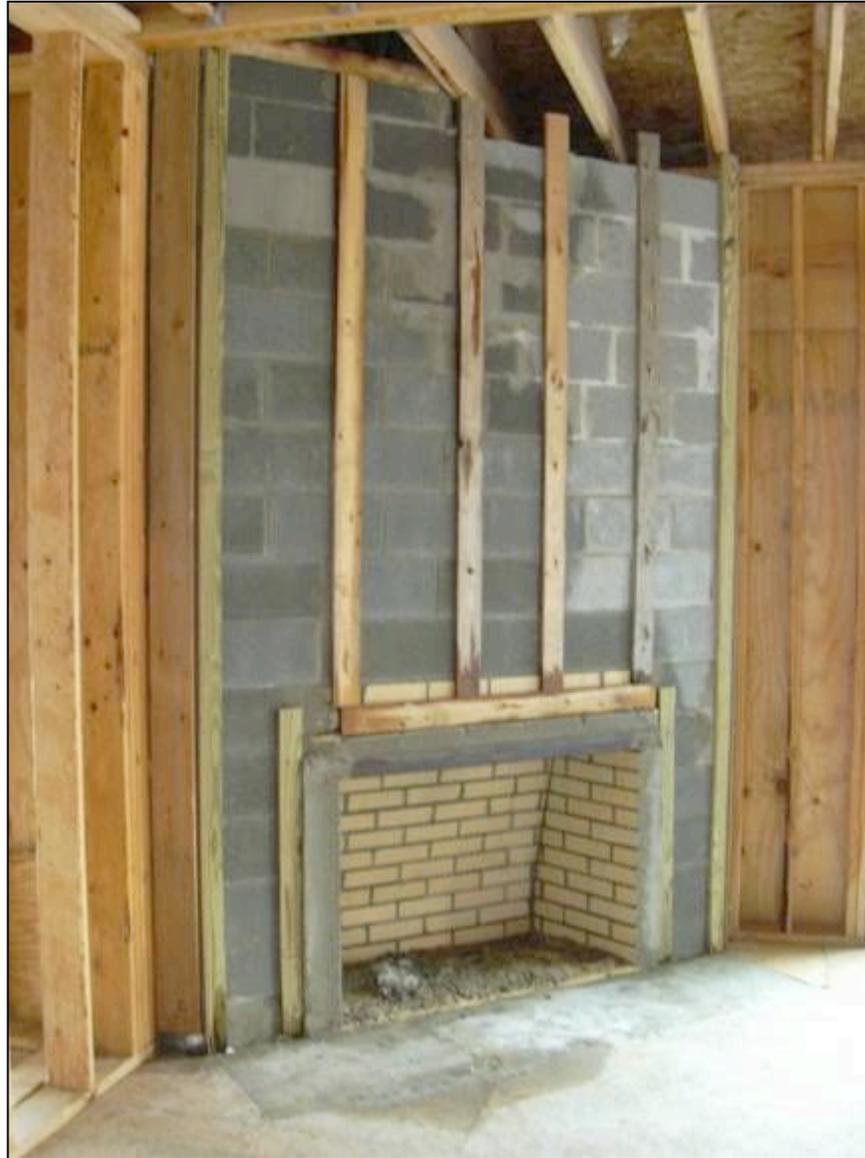
Wood burning
fireplace -
3/4" furring strips
open
to attic above

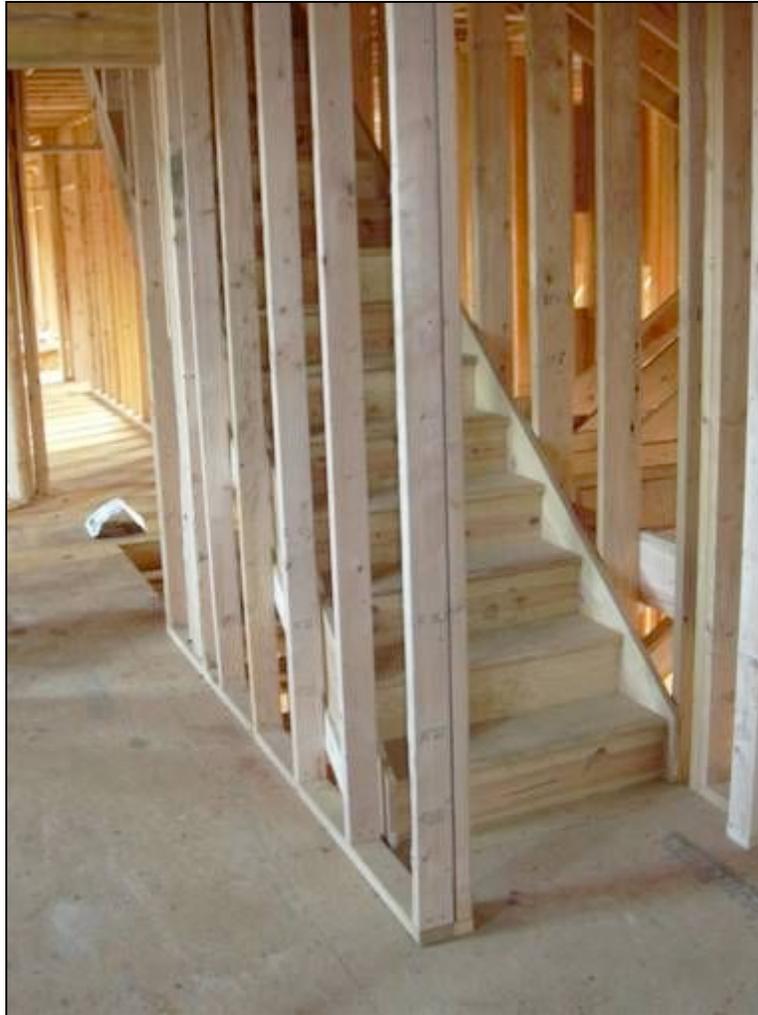
Stair to third floor open to kneewall and interior wall.

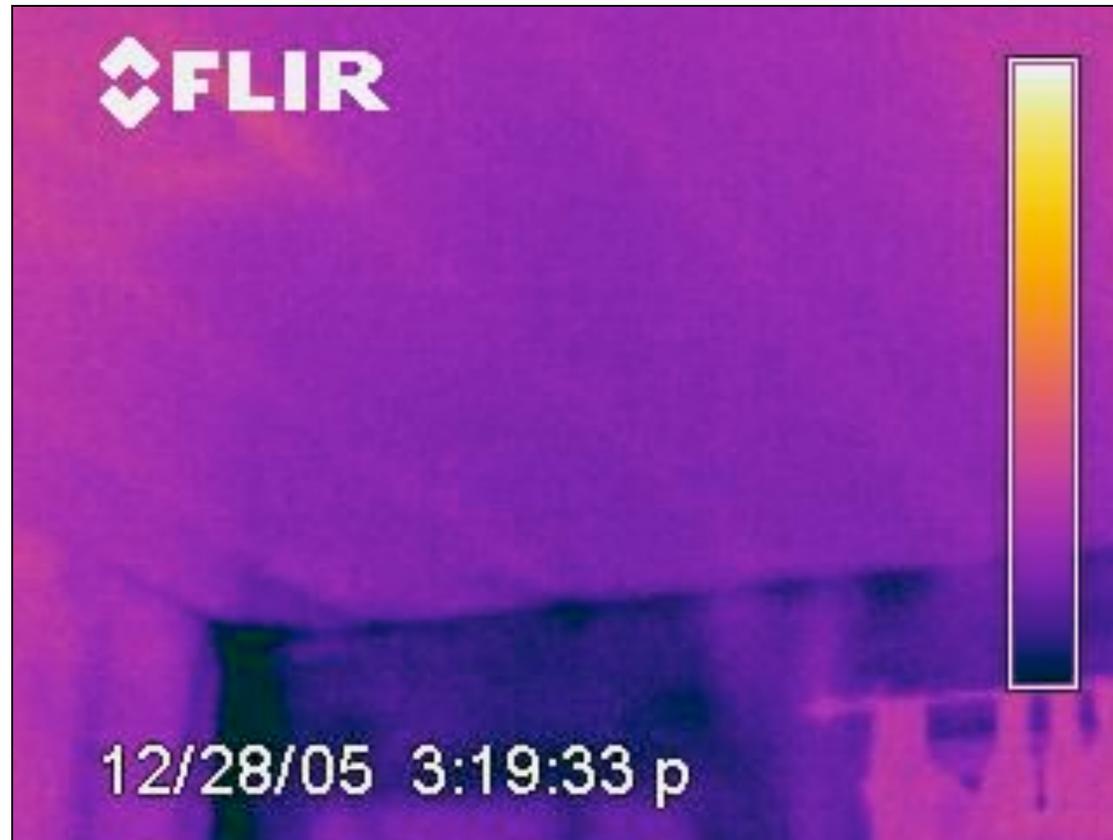
Cold air between heated floors - coming in from porch across front of house.

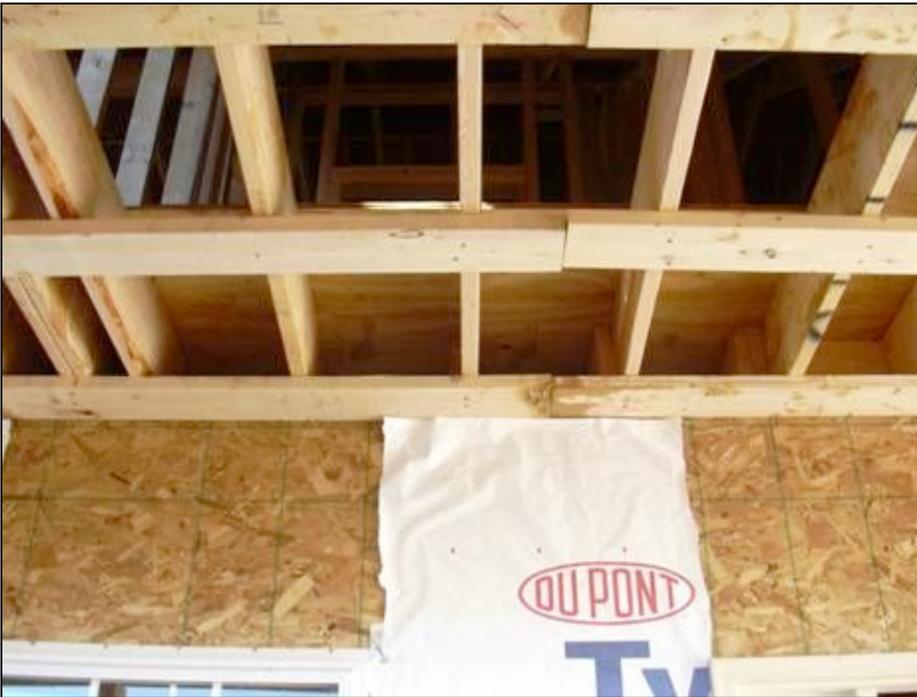
From outside, porch is open into 'Cape Cod' area of the second floor.

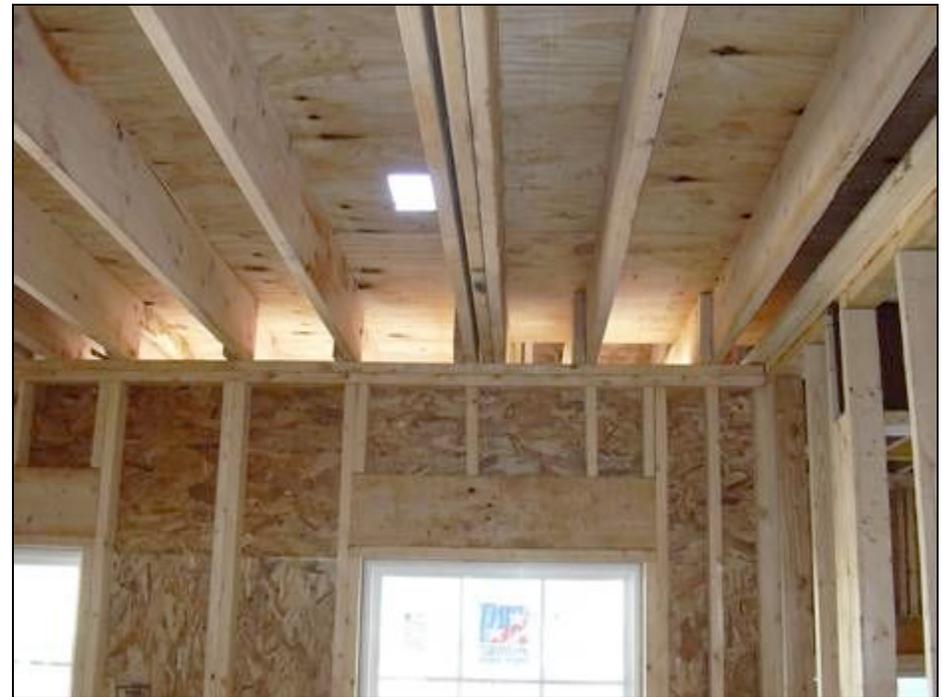
From inside, heated floor above is exposed to outside air.

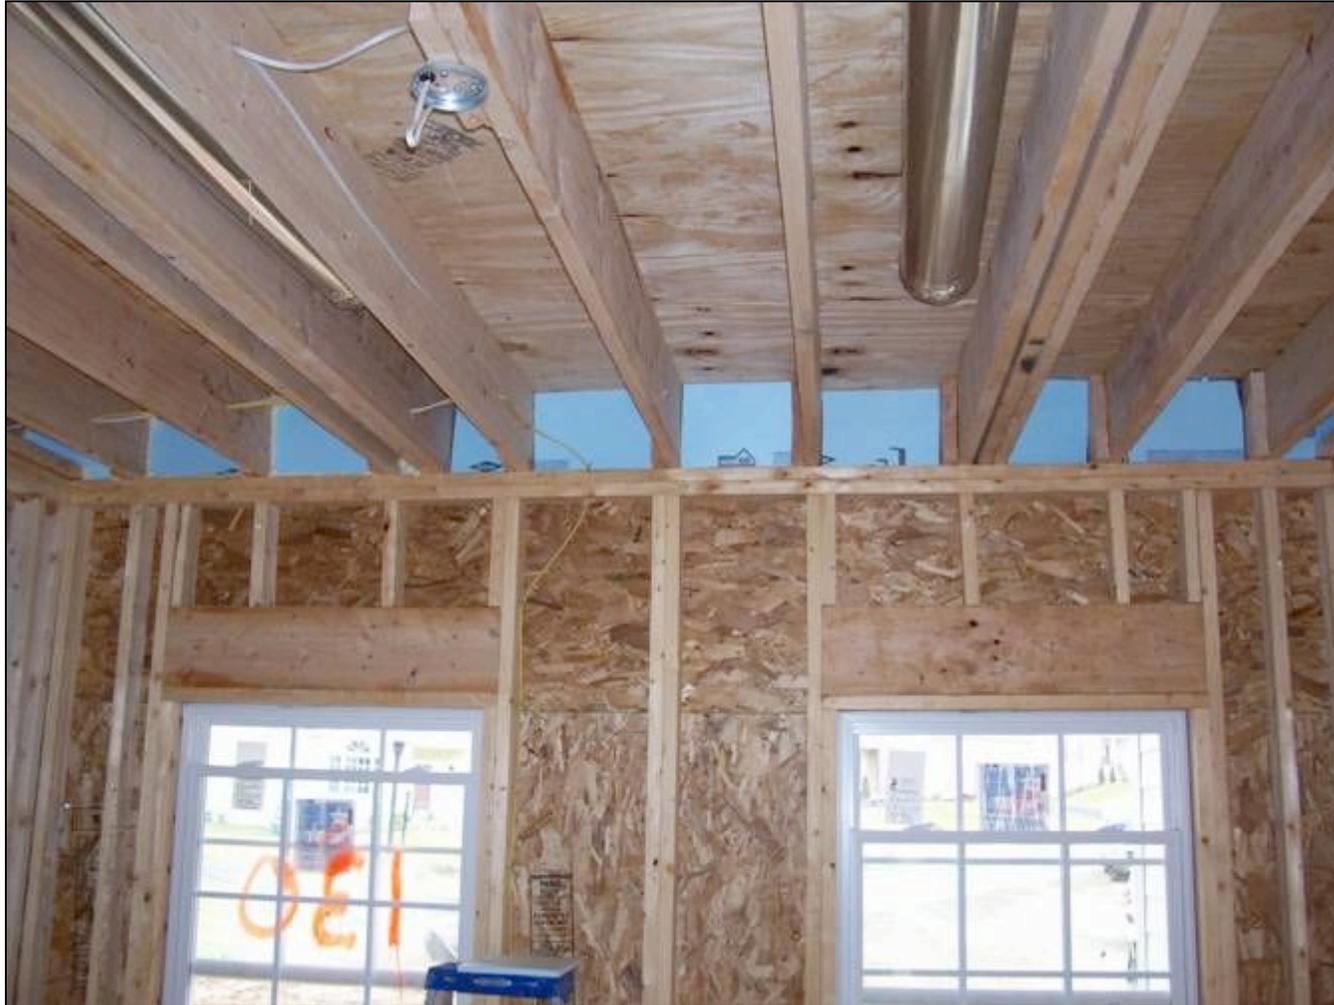
Air dams installed - ready for insulation.

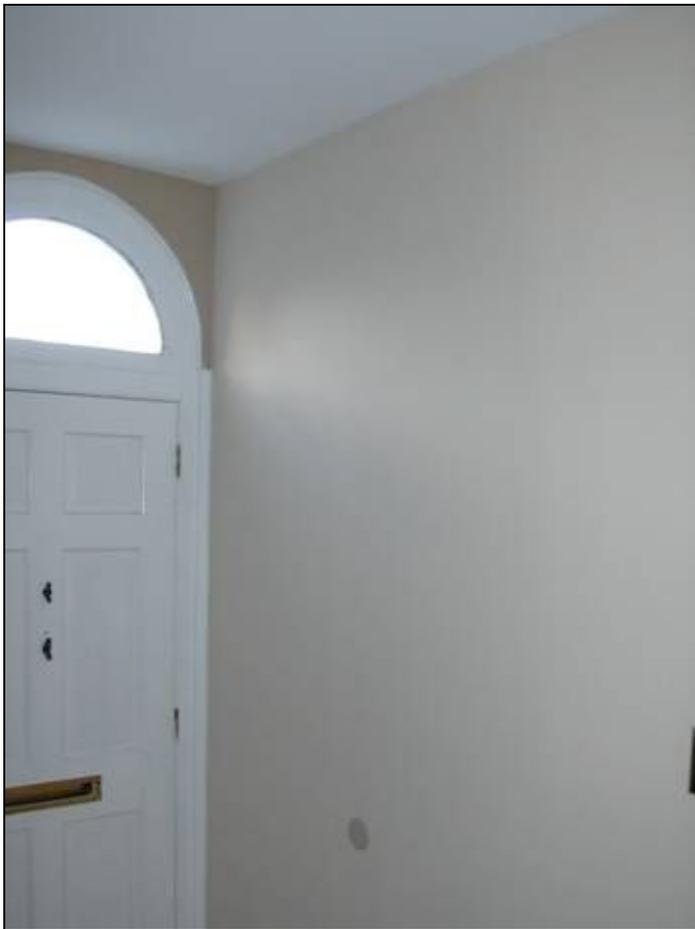
Front door at party wall.

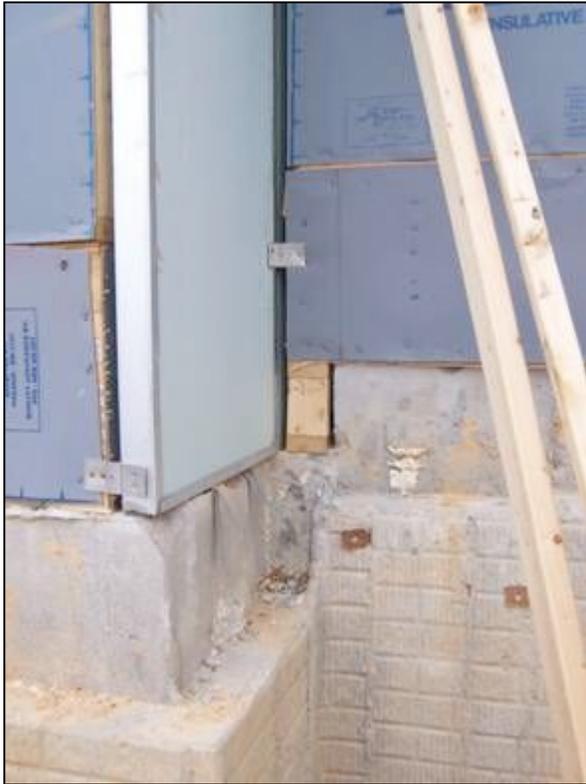
From the outside, corner between 2 units will get covered by 'J' channel siding, but will still leak air.

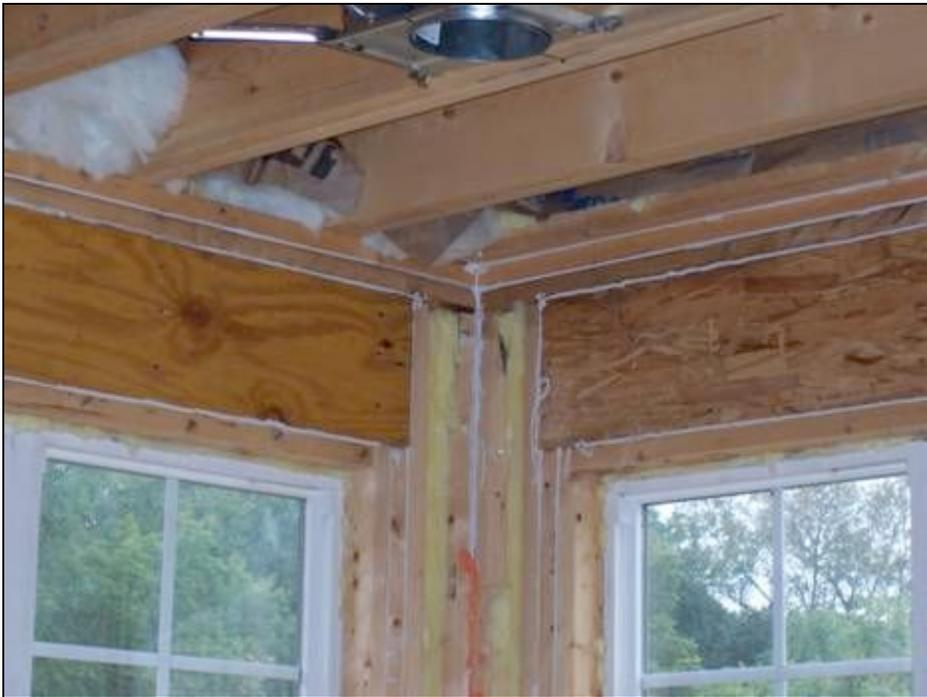
Caulk where not necessary.

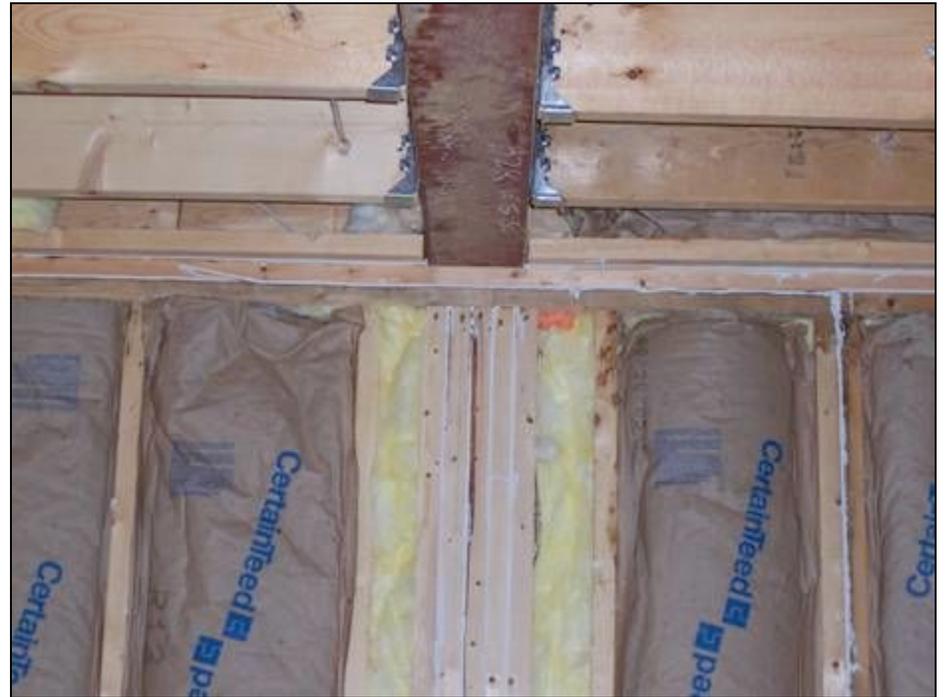
Caulk where not necessary.
Wasted time and money.

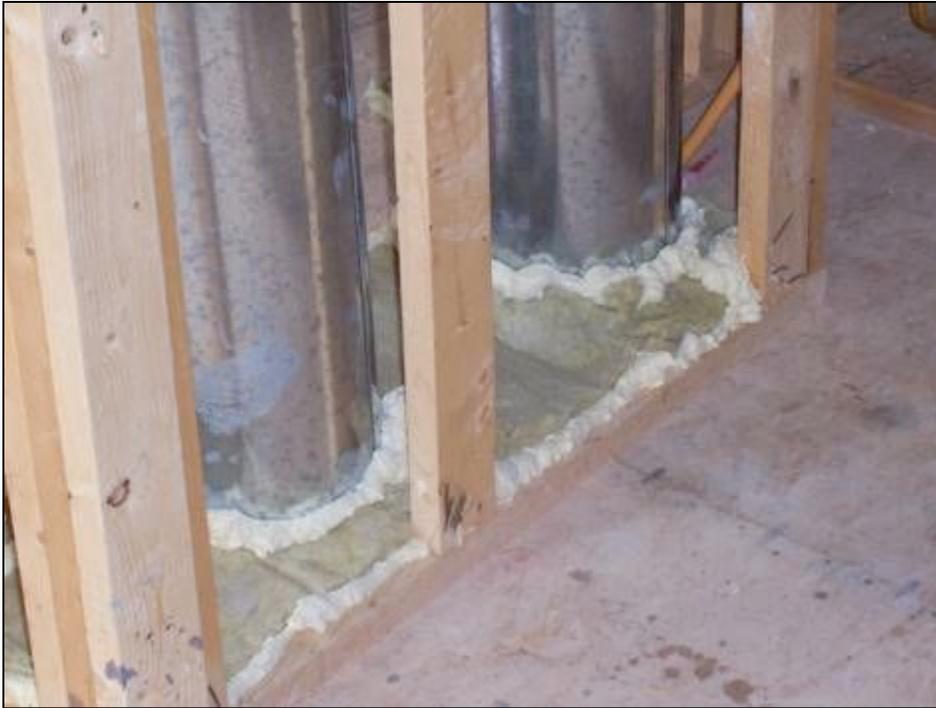
Airtight foam on pervious rock wool.

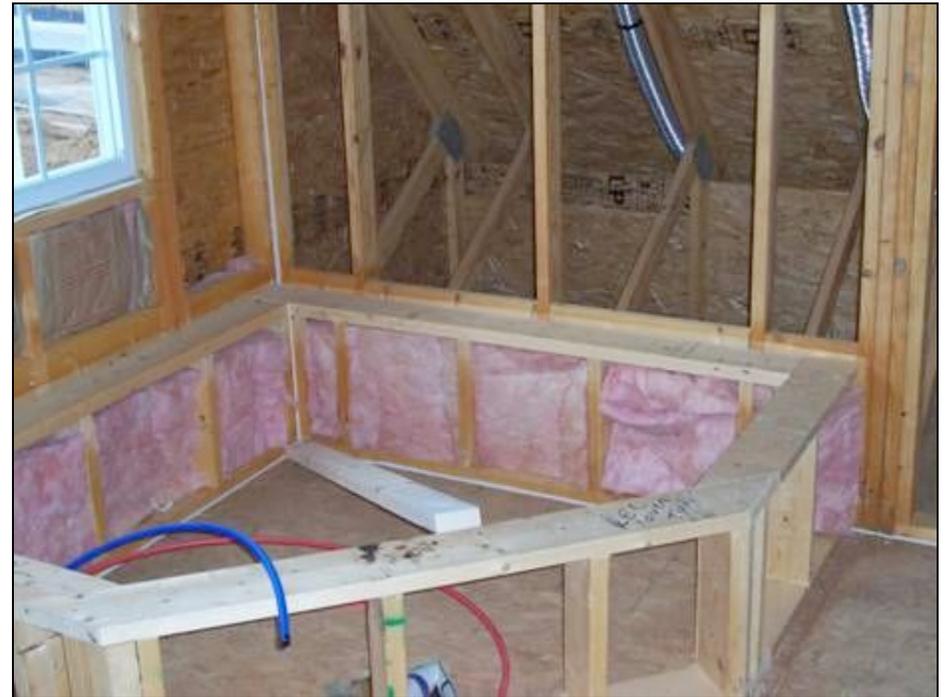
Plenty of caulk, but no airtight back on insulation in attic.

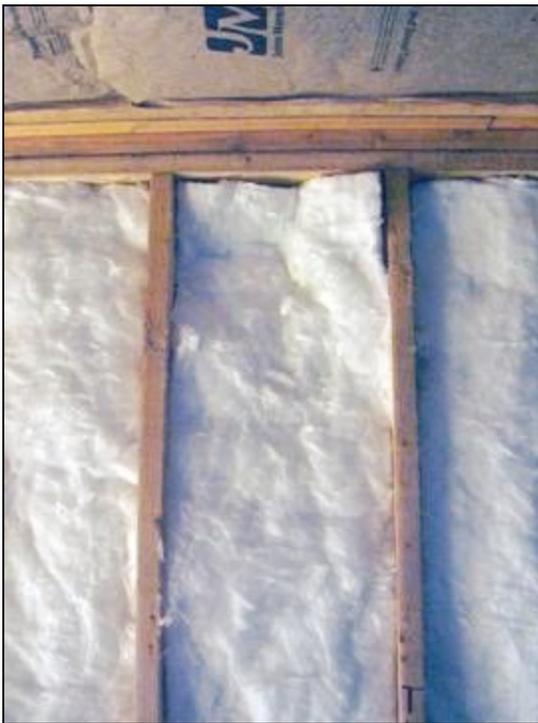
Sound insulation in place.

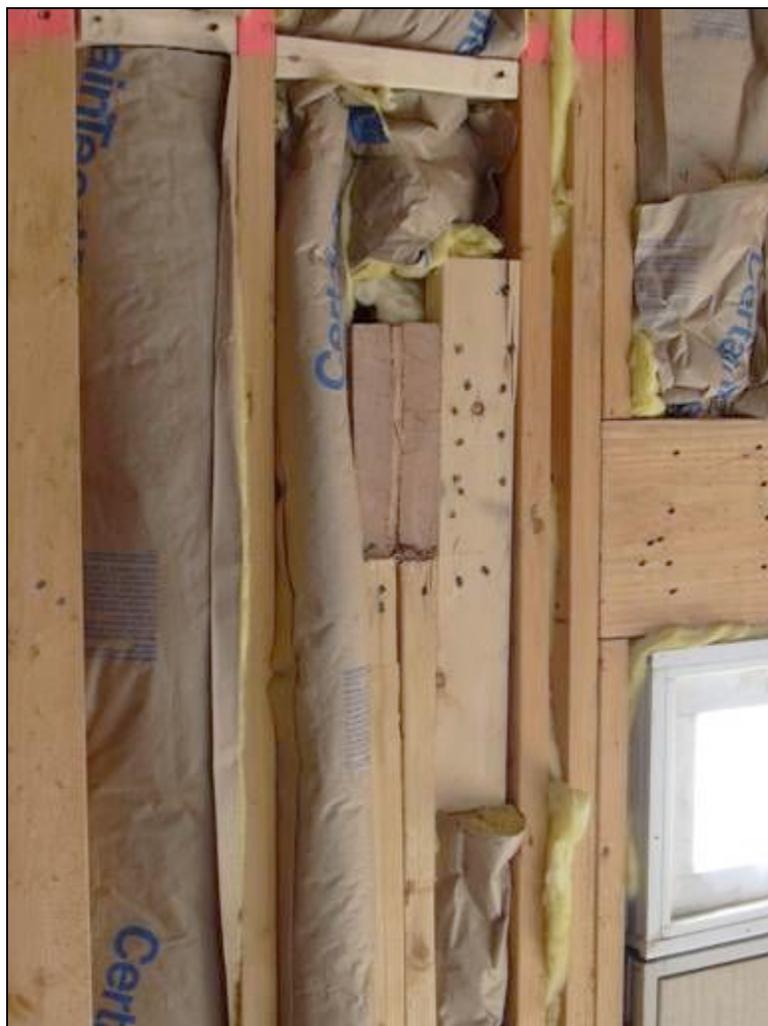
Insulation in place.

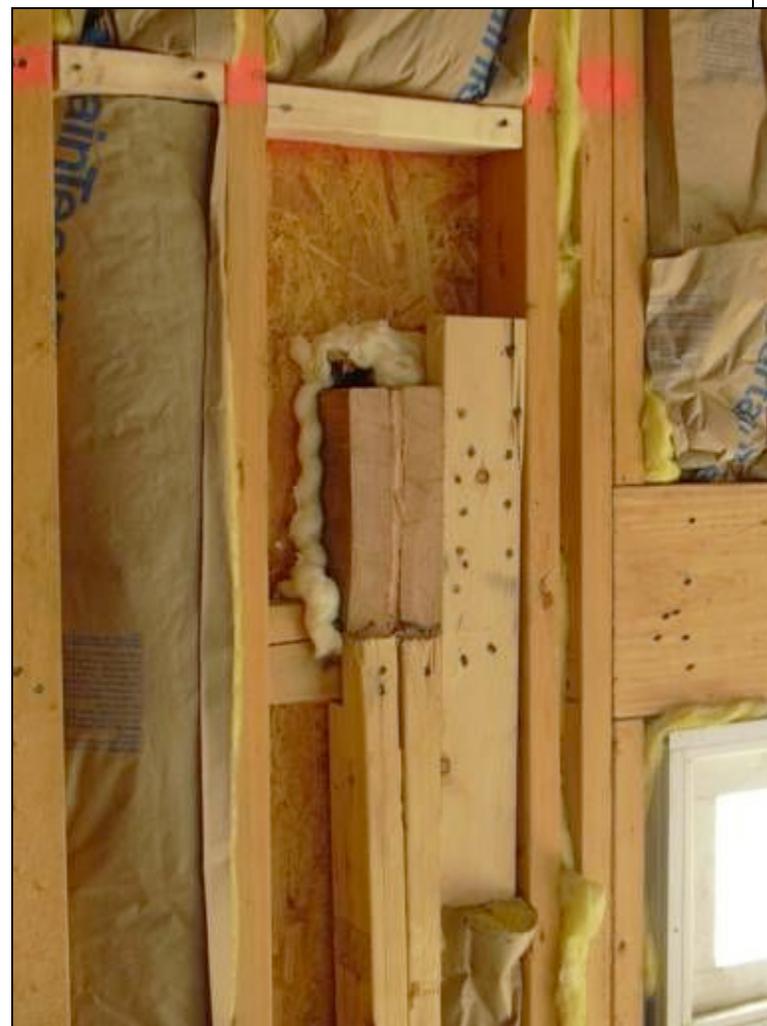
End of front porch beam sealed.

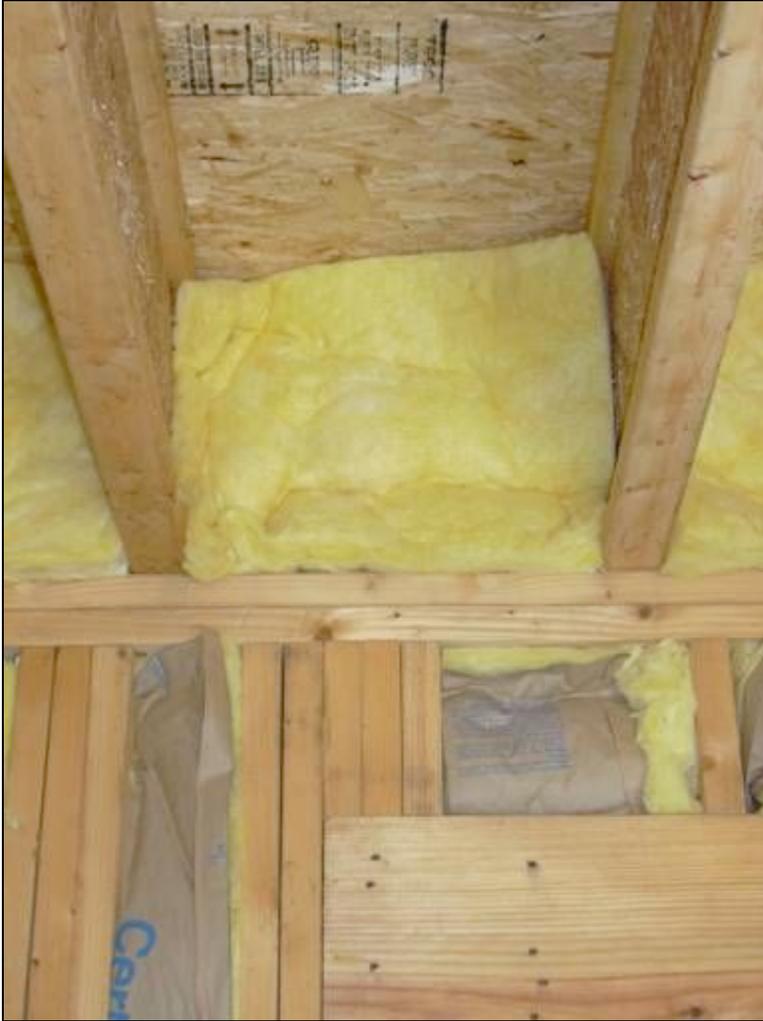
Insulation in place.

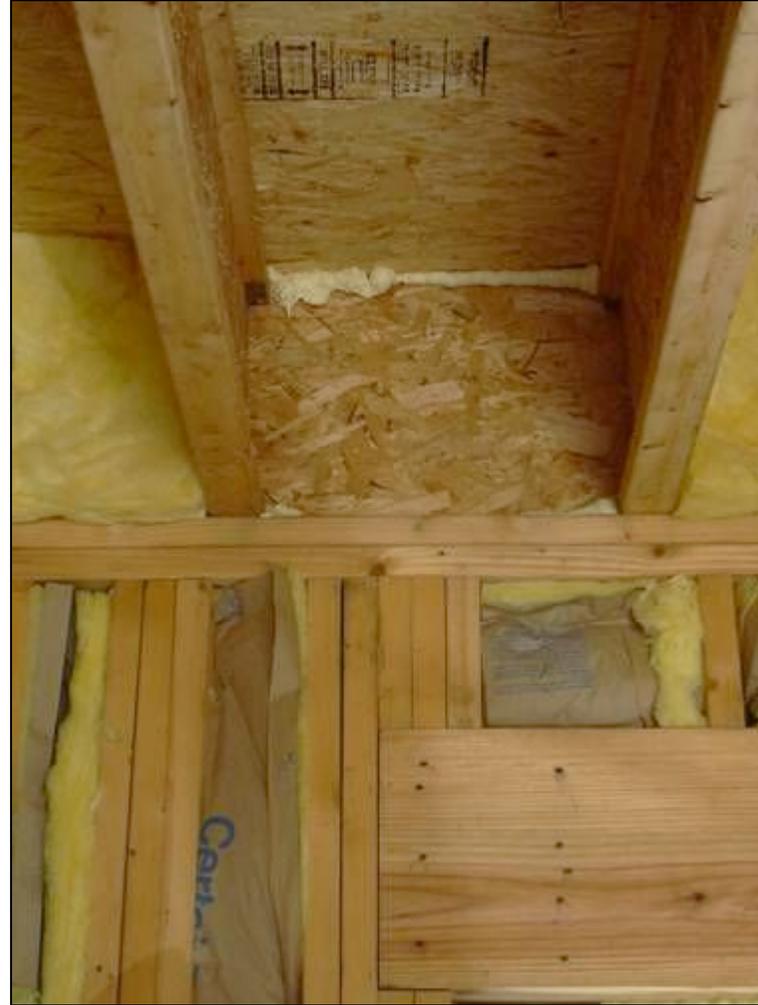
Band joist between floors sealed.
